Roseville Anglican College Sports & Wellbeing Centre

Vibration Monitoring Report 1

Project ID	20220917.5
Document Title	Vibration Monitoring Report 1
Attention To	Taylor Construction Group Pty Ltd

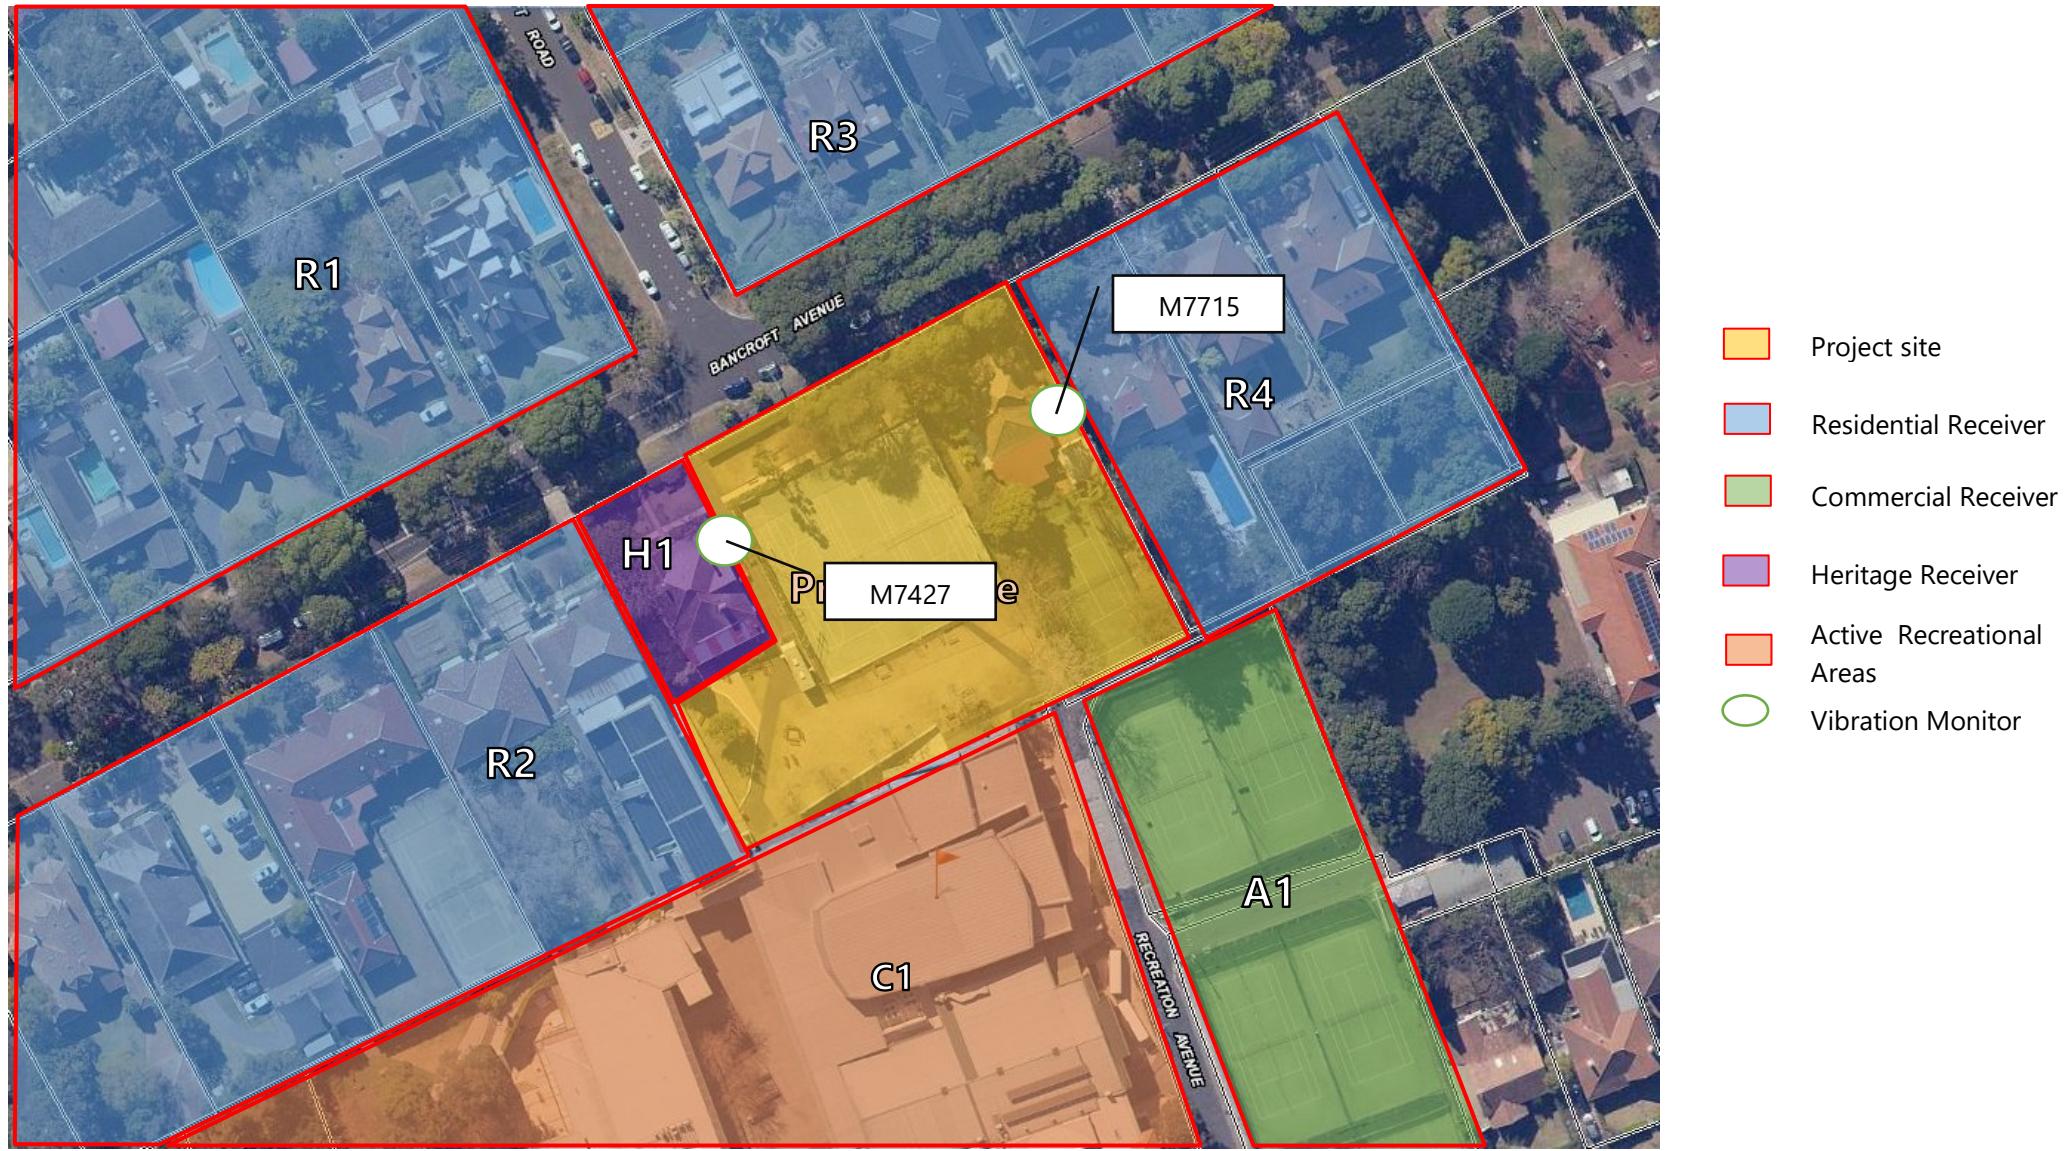
Figure 1: Aerial view of the project site and the sensitive receivers (Sourced : SixMaps)

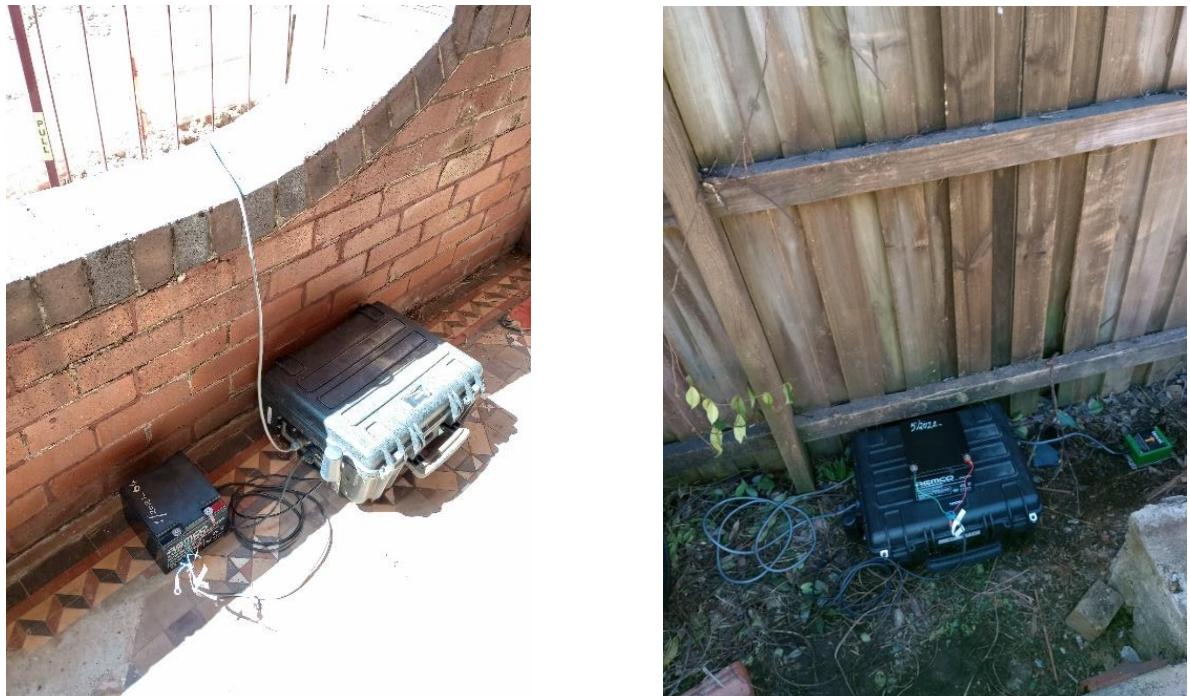
Figure 2: M7427(left) on the Heritage building on the western boundary of the project site & M7715(right) on the eastern boundary of the project site

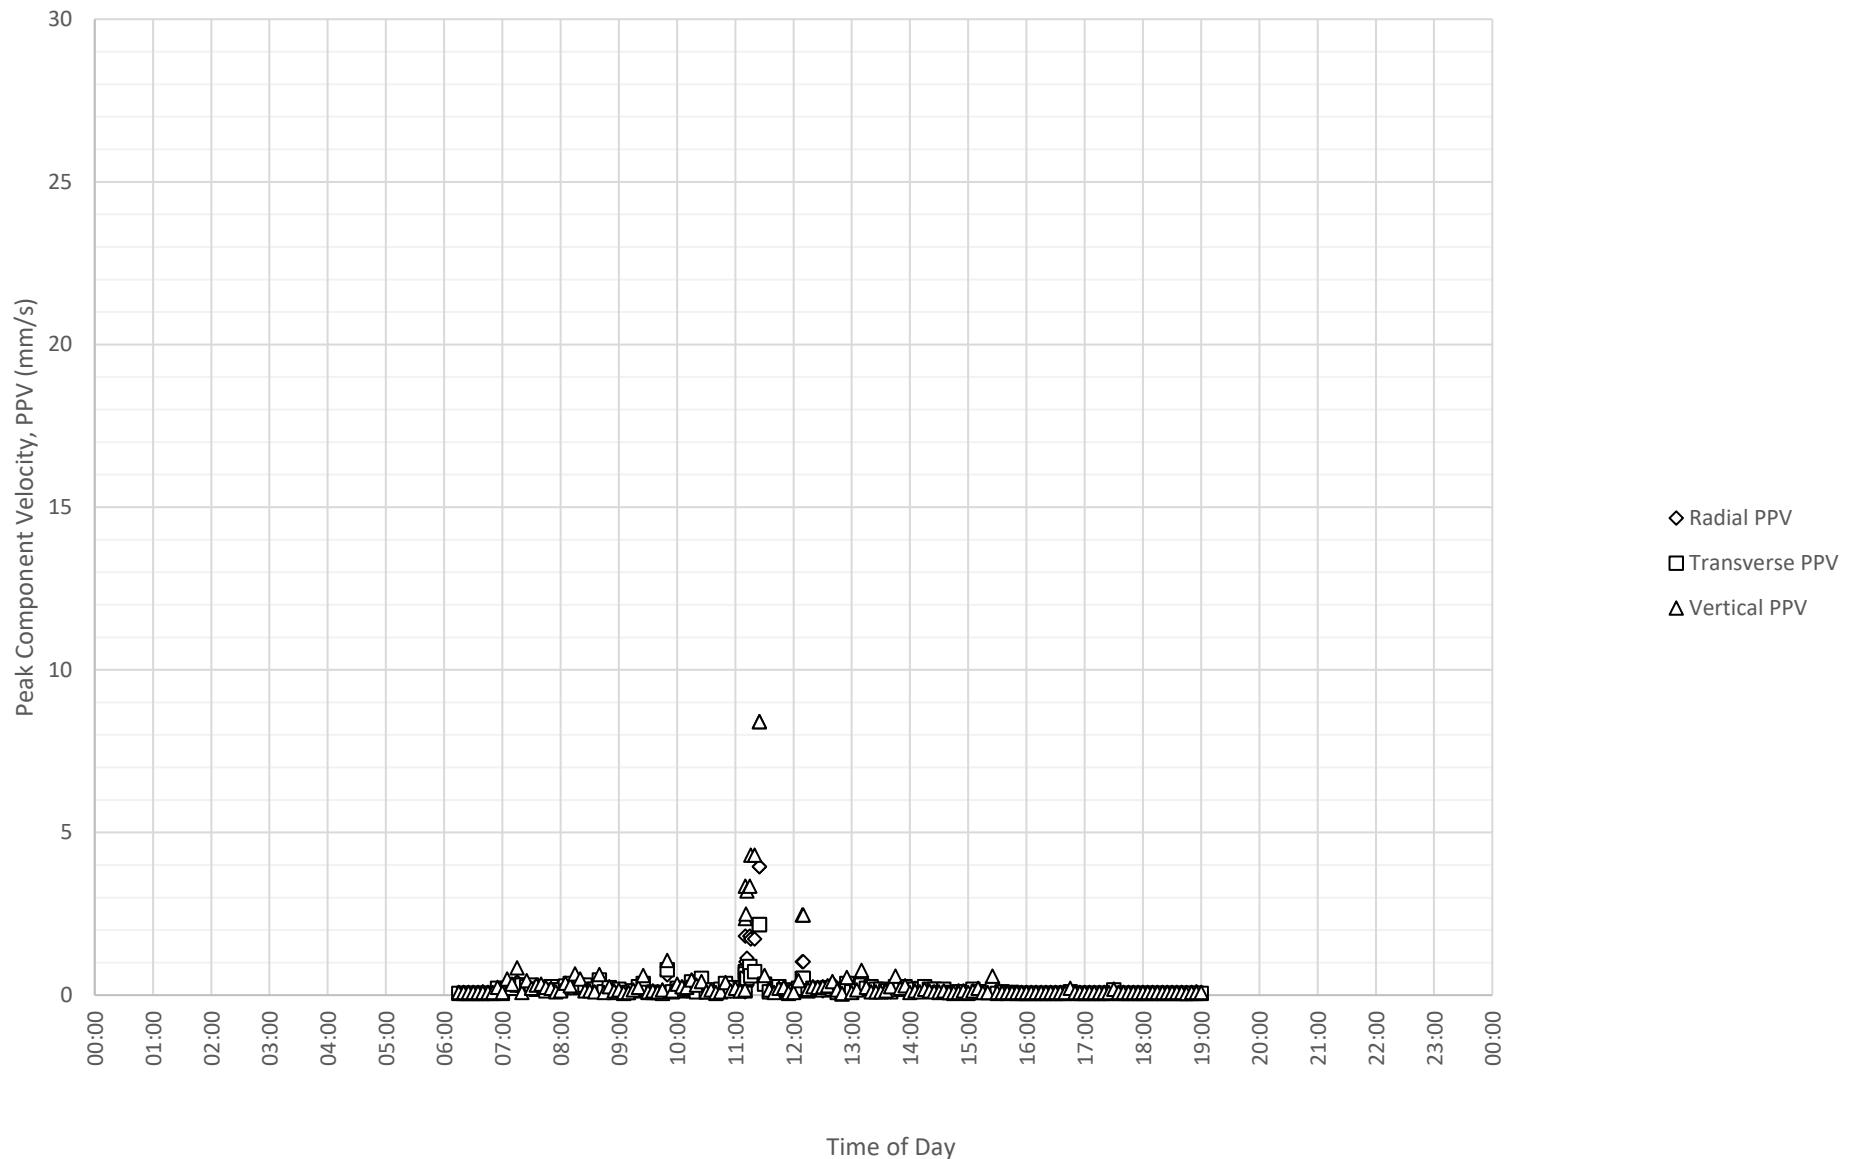
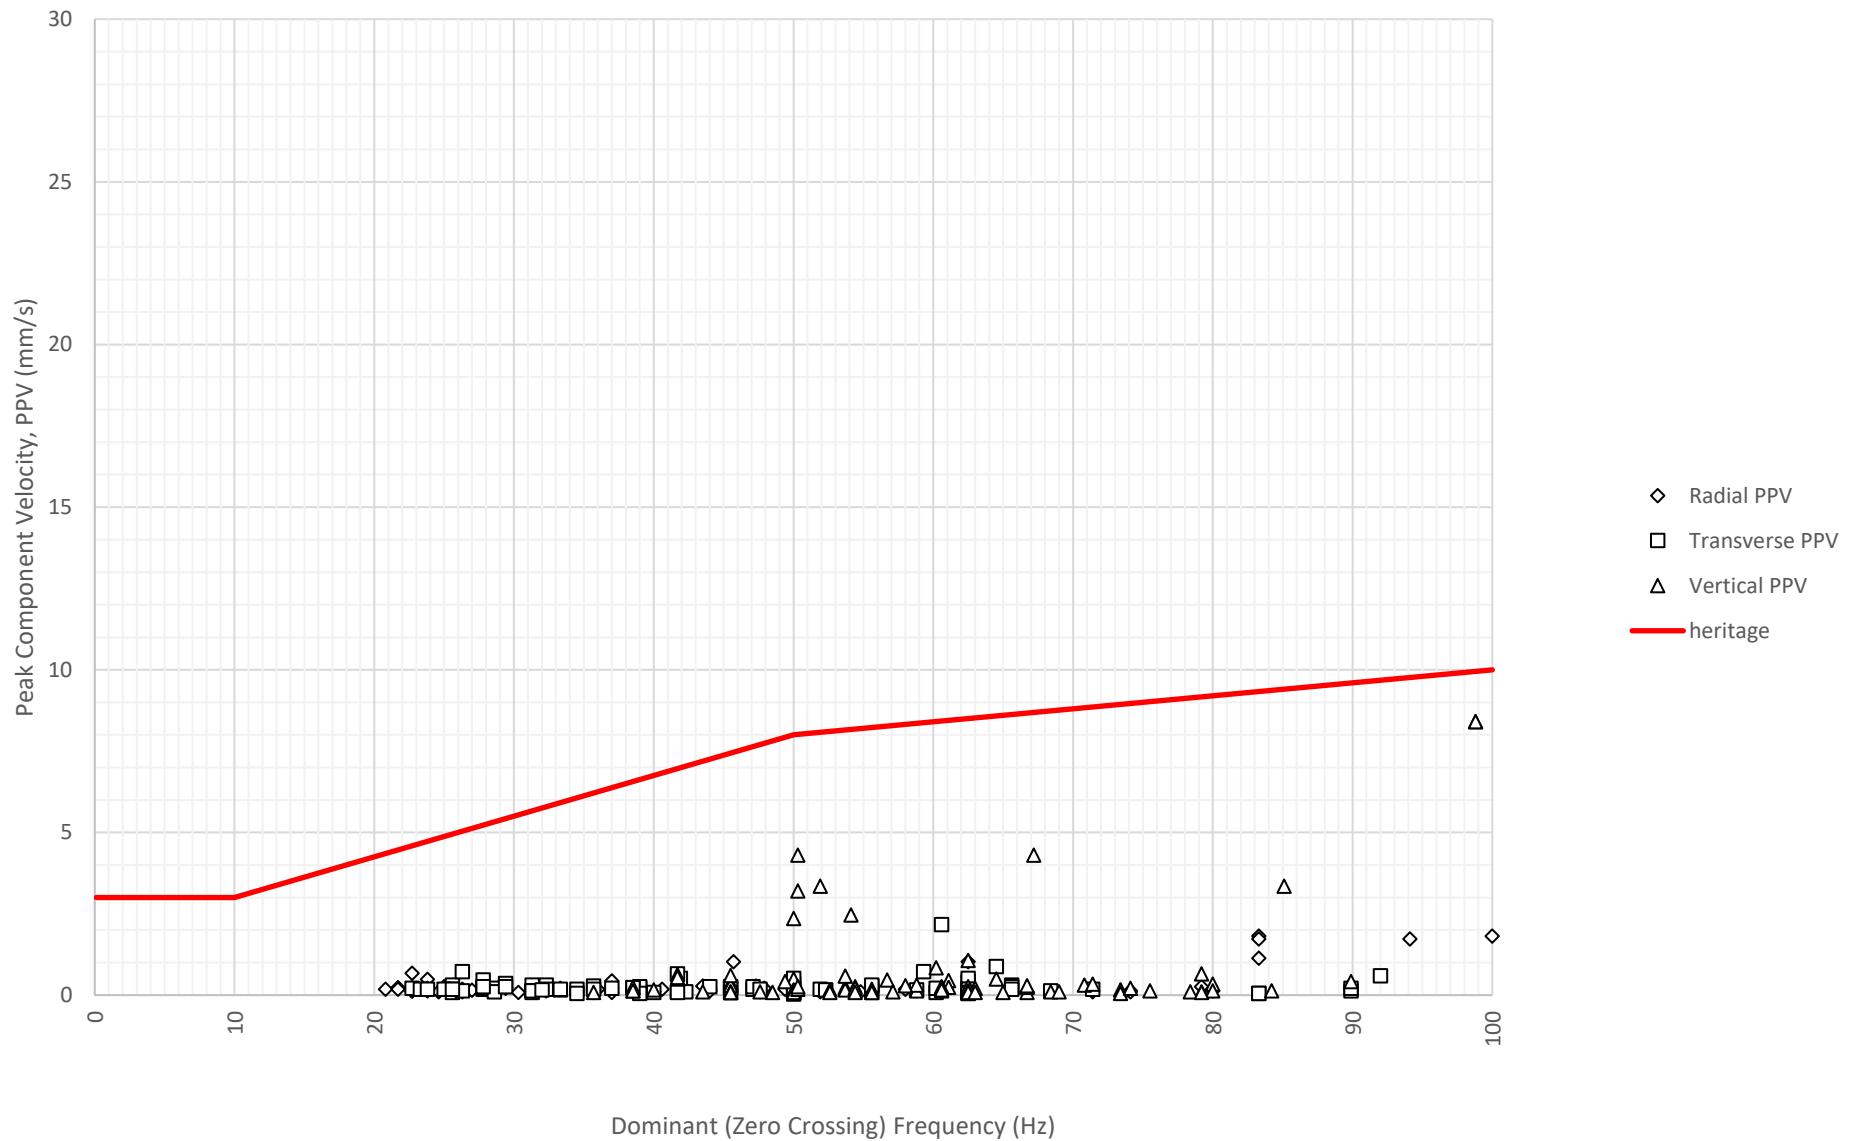
Daily Monitored Vibration Levels at M7427 Heritage on 19-08-2022

Frequency Content of Vibration Levels at M7427 Heritage on 19-08-2022

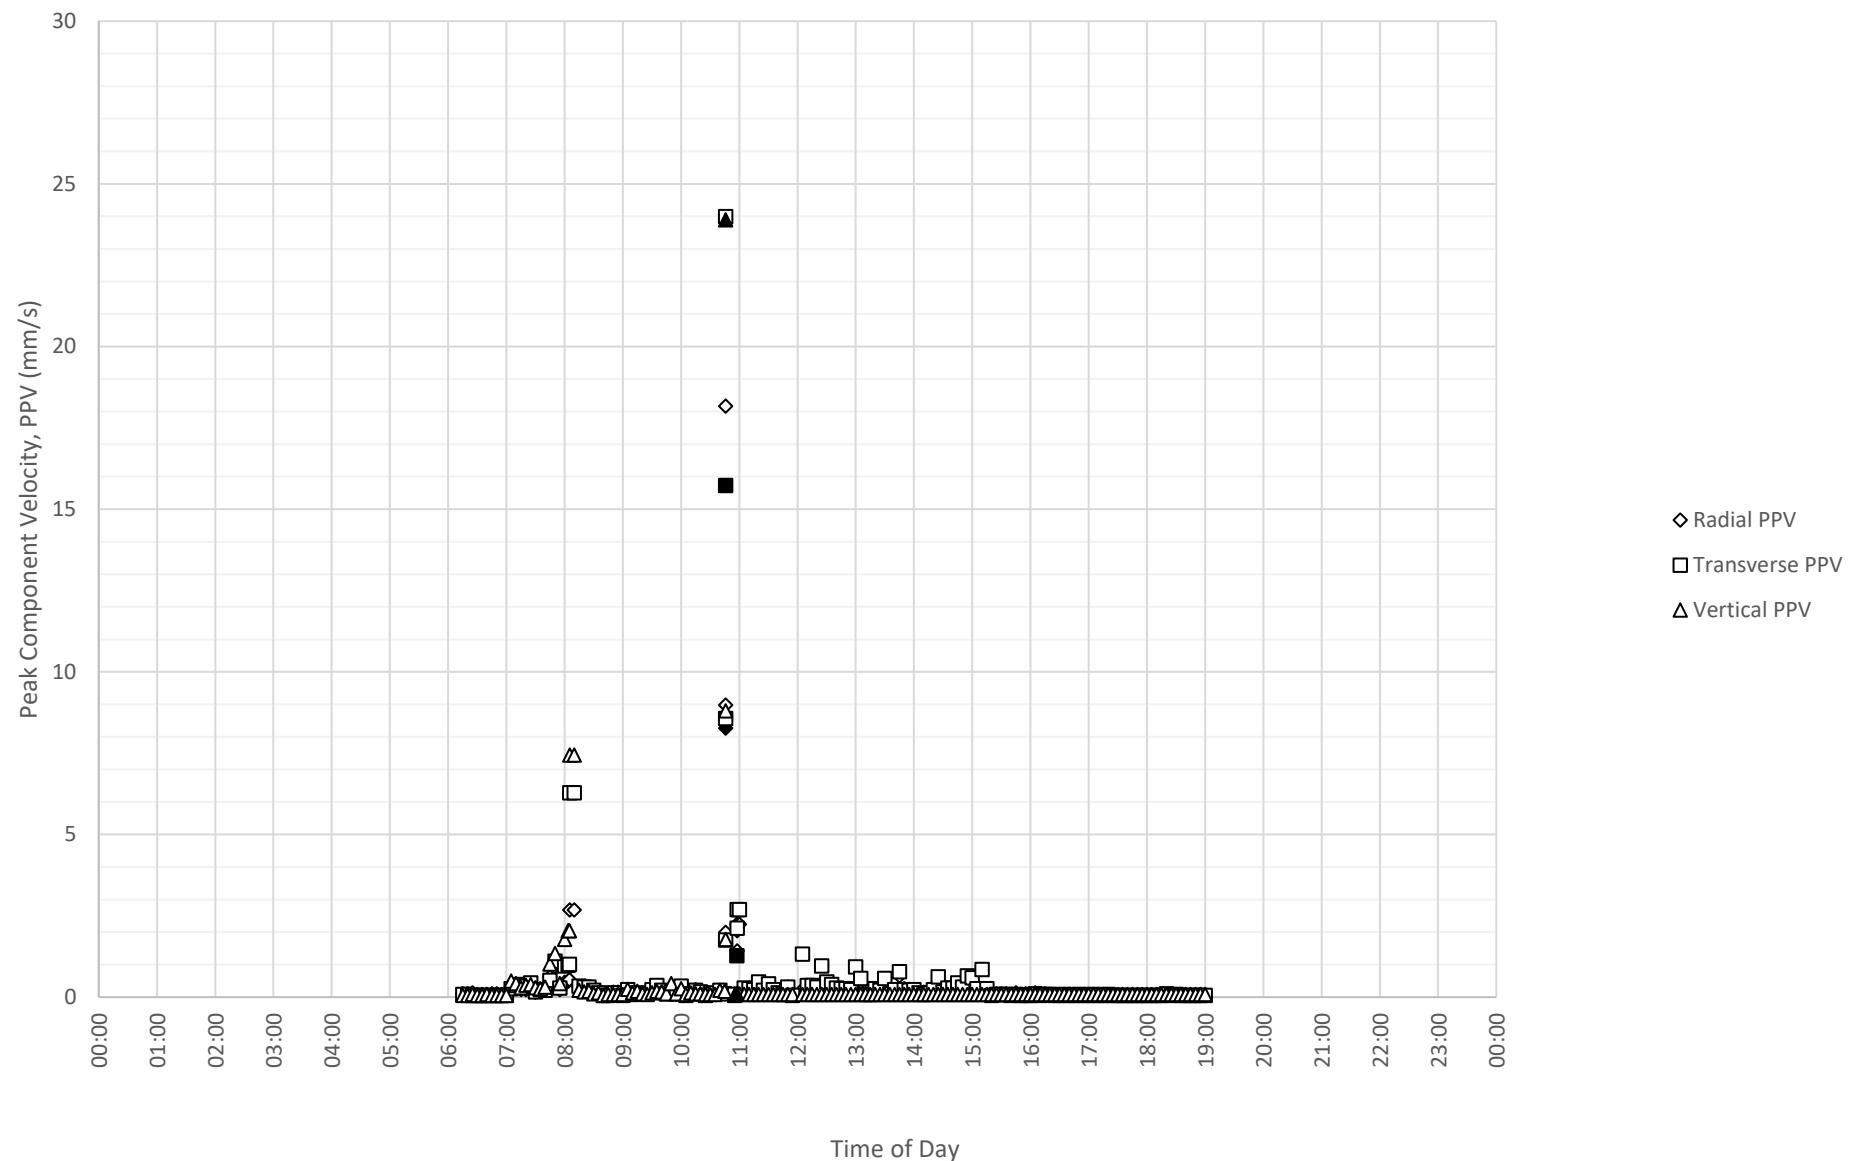
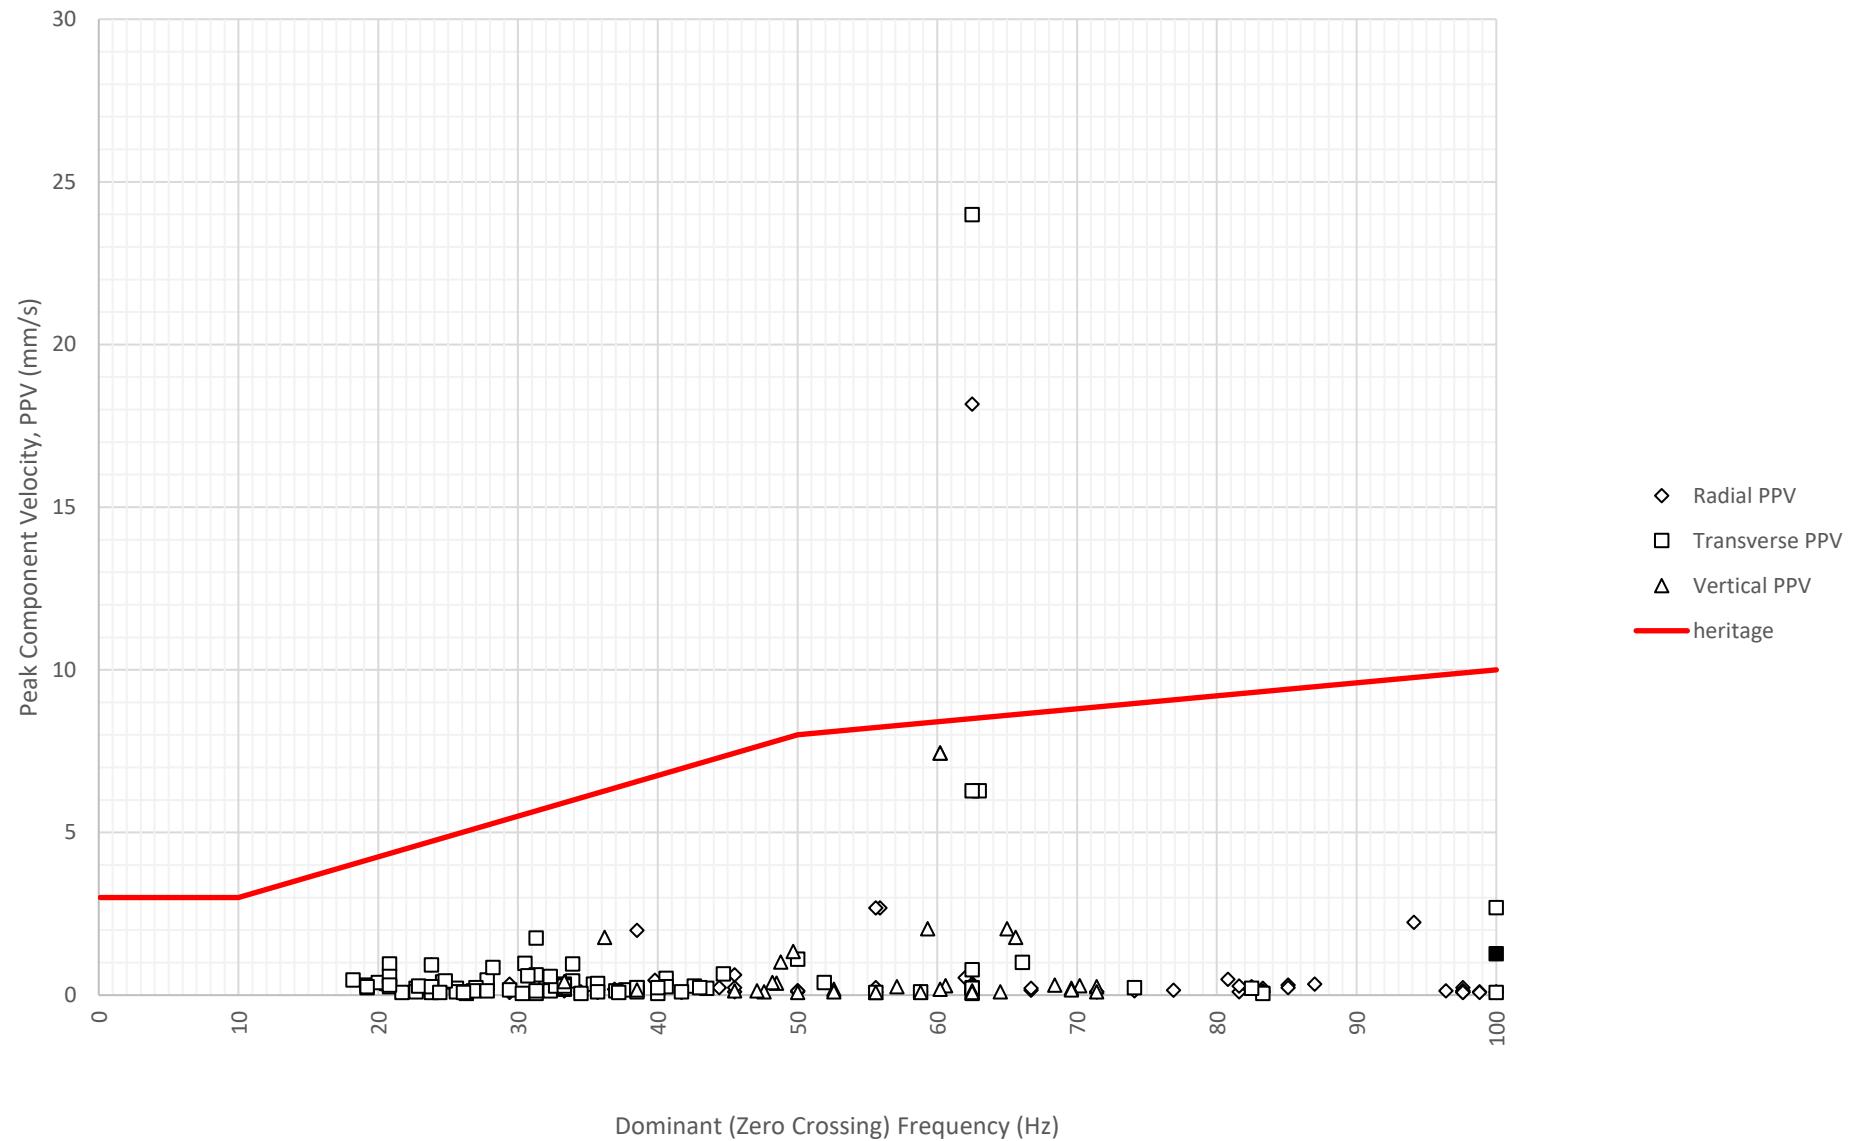
An isolated exceedance was measured on the 22nd August 2022 between the hours of 10:45am to 11:00am. It was informed by the site manager the event was due to materials and equipment's were being moved along western boundary of the project site near the monitor and not due to excavation and piling works.

Daily Monitored Vibration Levels at M7427 Heritage on 22-08-2022

Frequency Content of Vibration Levels at M7427 Heritage on 22-08-2022

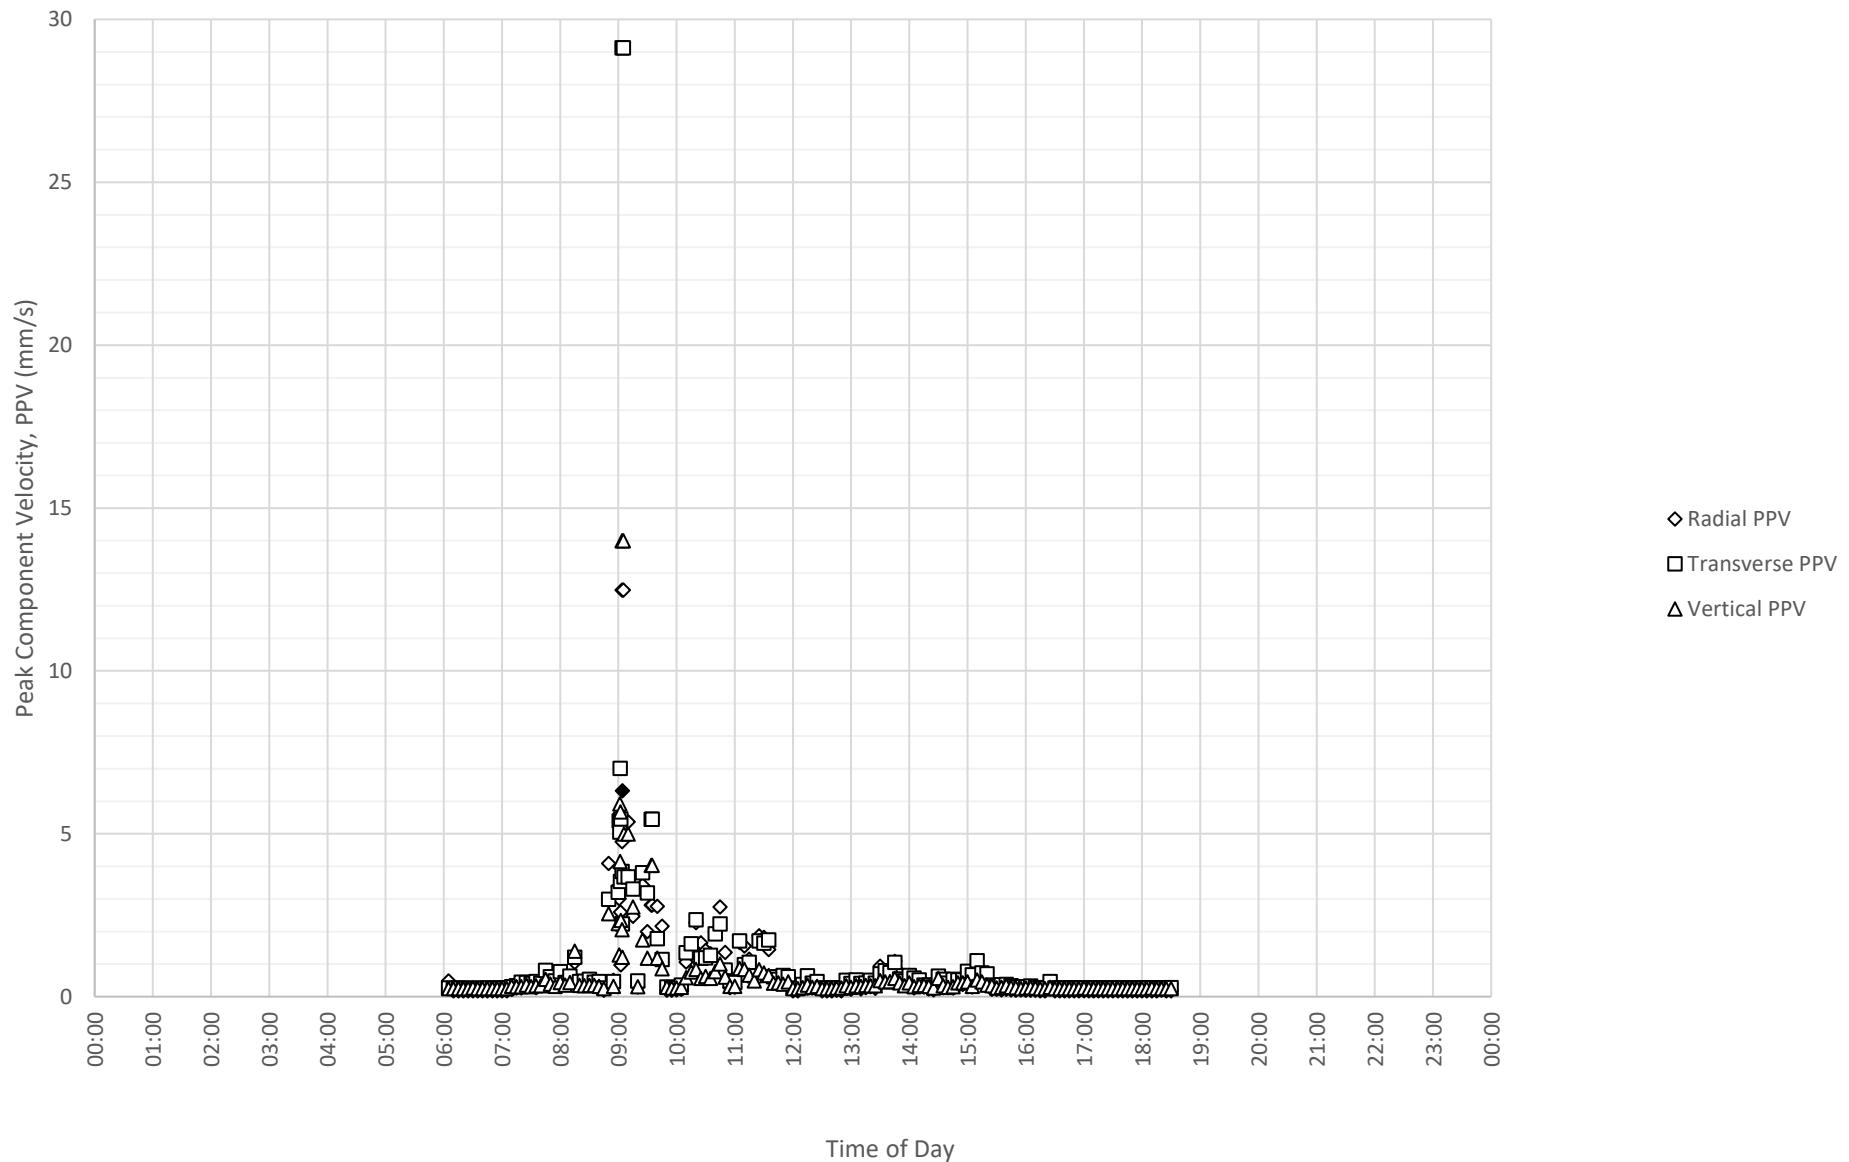
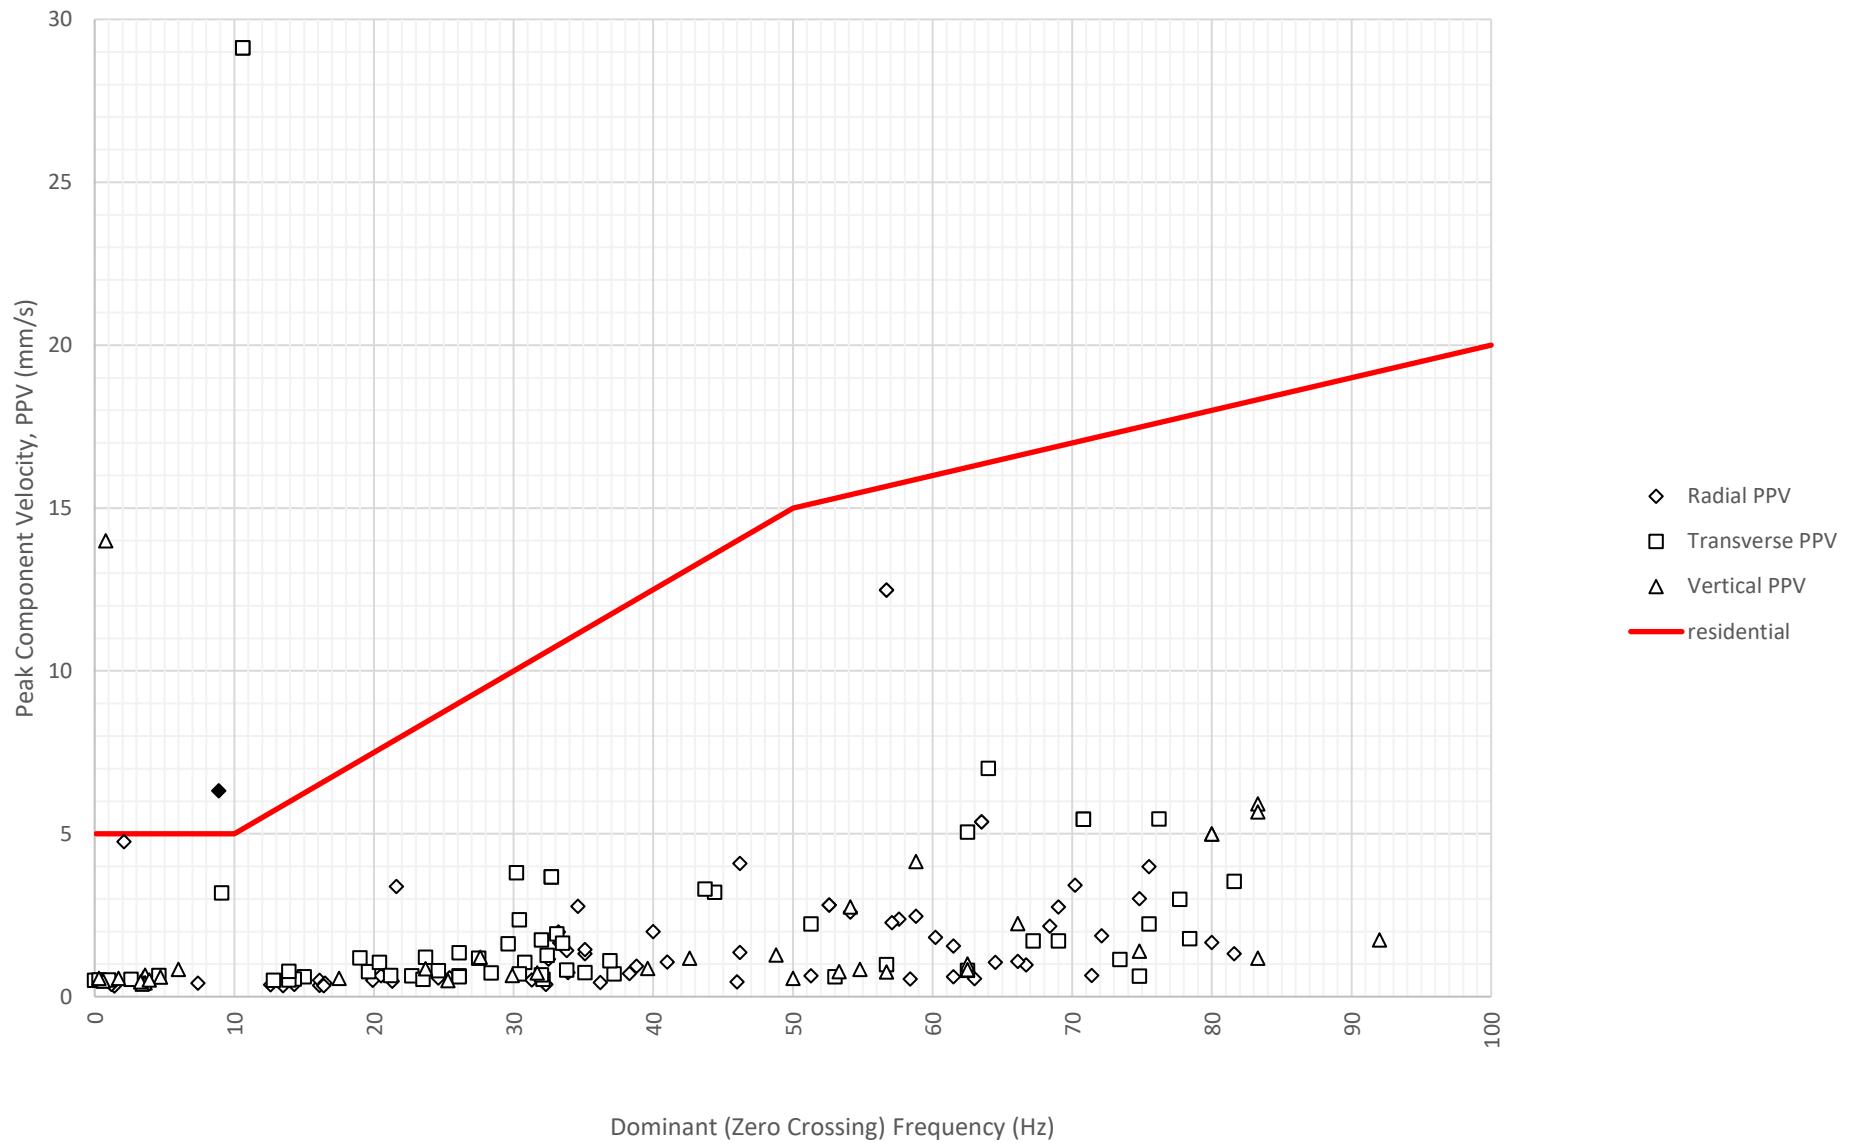
- 19th August 2022 9:00am to 9:30am.
- 22nd August 2022 between 7:00am to 7:30am.
- 24th August 2022 between 2:30pm to 3:00pm.

These isolated short-term exceedances were assessed with Taylor Construction and were due to demolition works being undertaken in the immediate location of monitor, which is offset from the residential property by approximately 5m. As a result, the localised demolition immediately adjacent to the monitor resulted in the artificial inflation of measured results. Notwithstanding, a visual inspection of the residential property is recommended, in addition to investigating the feasibility of relocating the monitor to the exact boundary of the residential premises. No other exceedances from the demolition works were measured for the rest of the monitoring period.

Daily Monitored Vibration Levels at M7715 on 19-08-2022

Frequency Content of Vibration Levels at M7715 on 19-08-2022

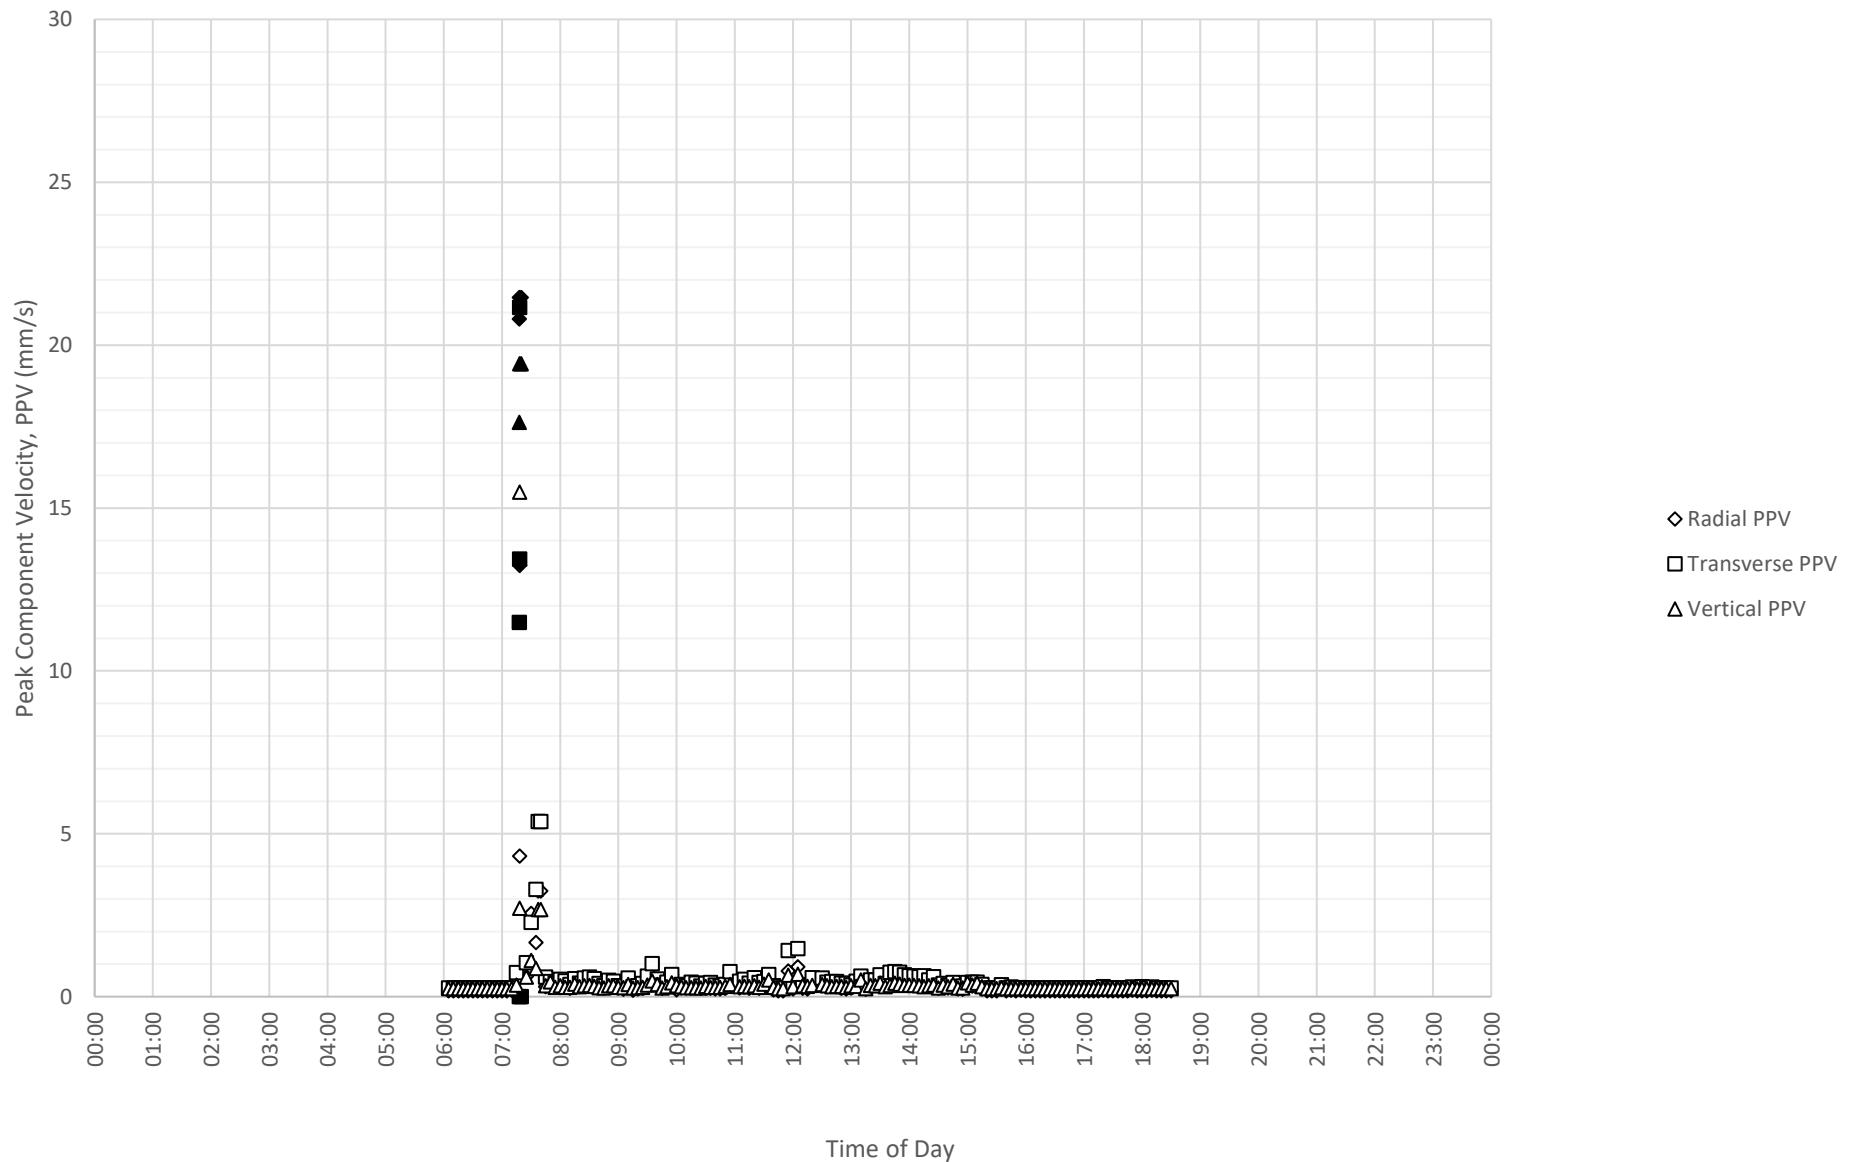
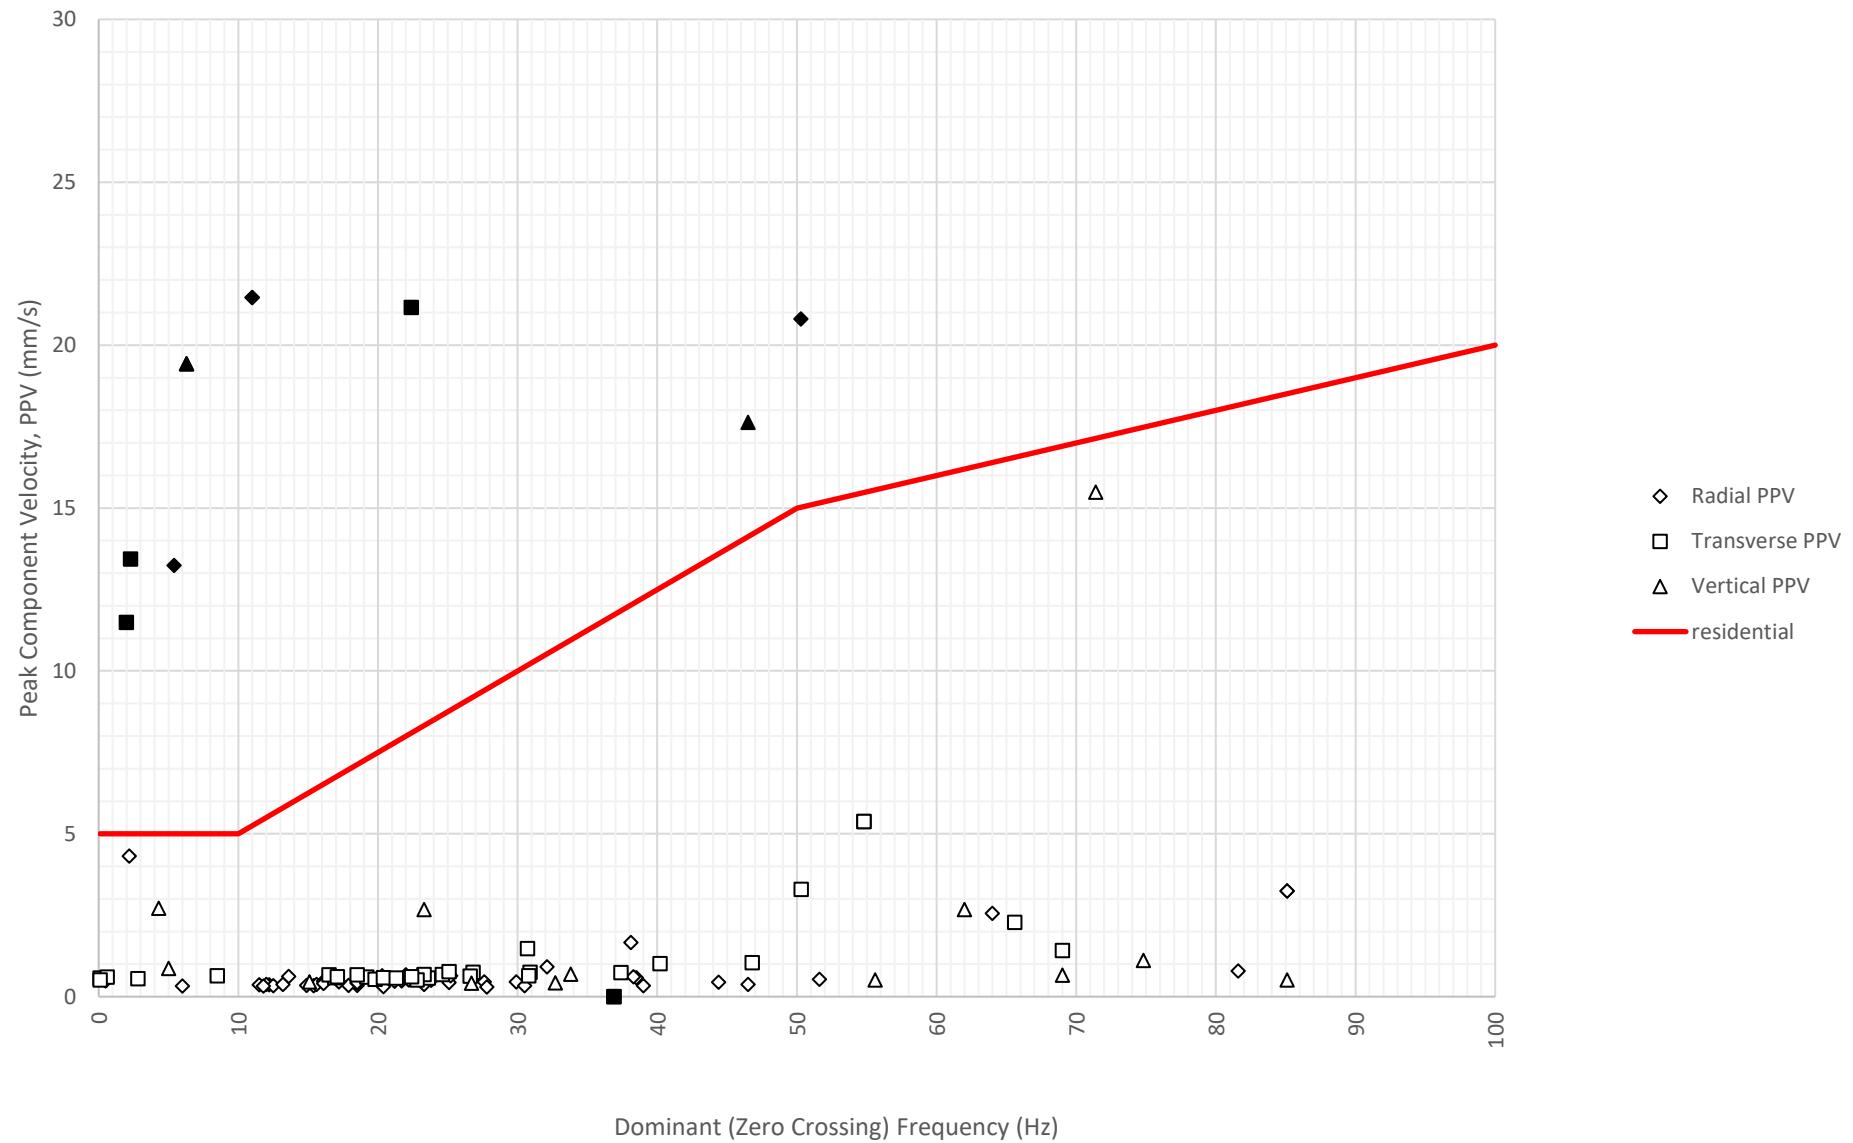
Daily Monitored Vibration Levels at M7715 on 22-08-2022

Frequency Content of Vibration Levels at M7715 on 22-08-2022
