Roseville Anglican College Sports & Wellbeing Centre

Vibration Monitoring Report 1

Project ID	20220917.5
Document Title	Vibration Monitoring Report 1
Attention To	Taylor Construction Group Pty Ltd

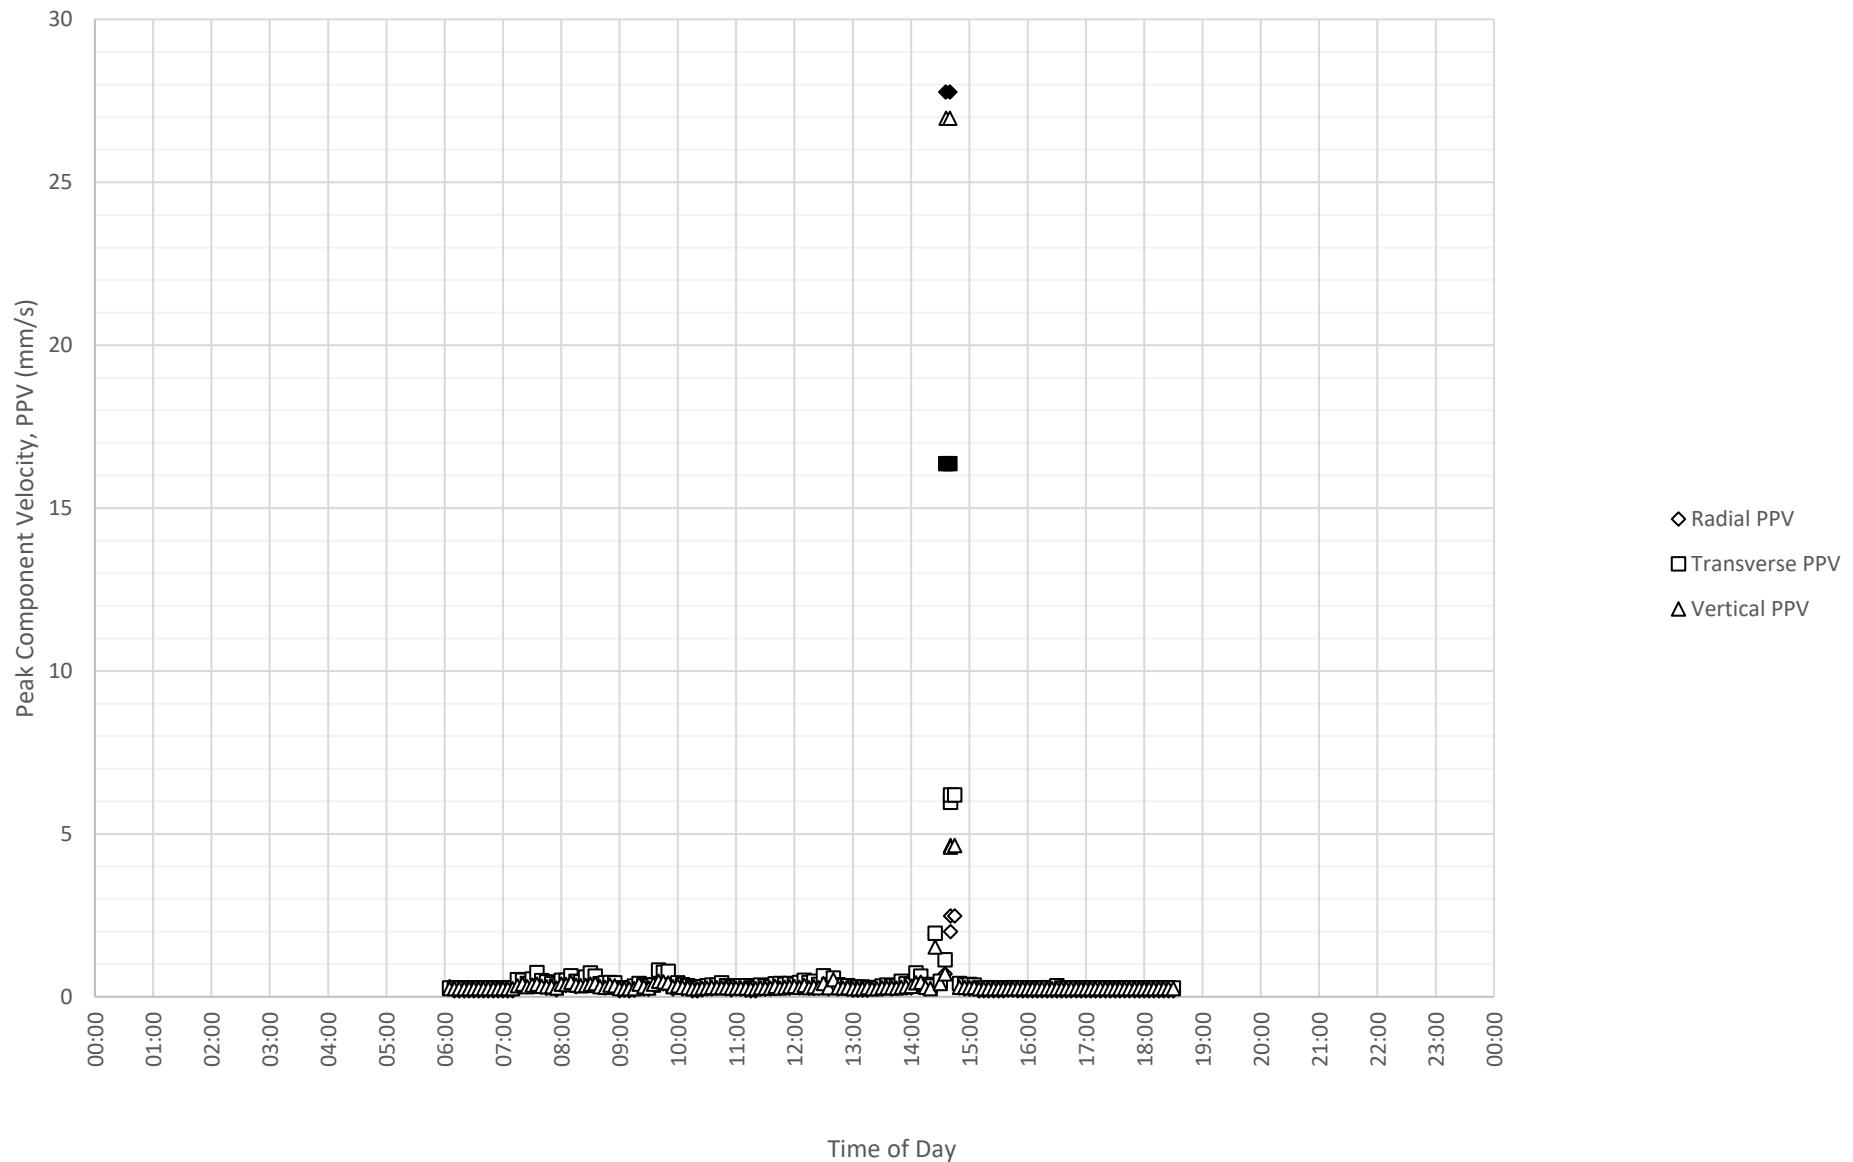
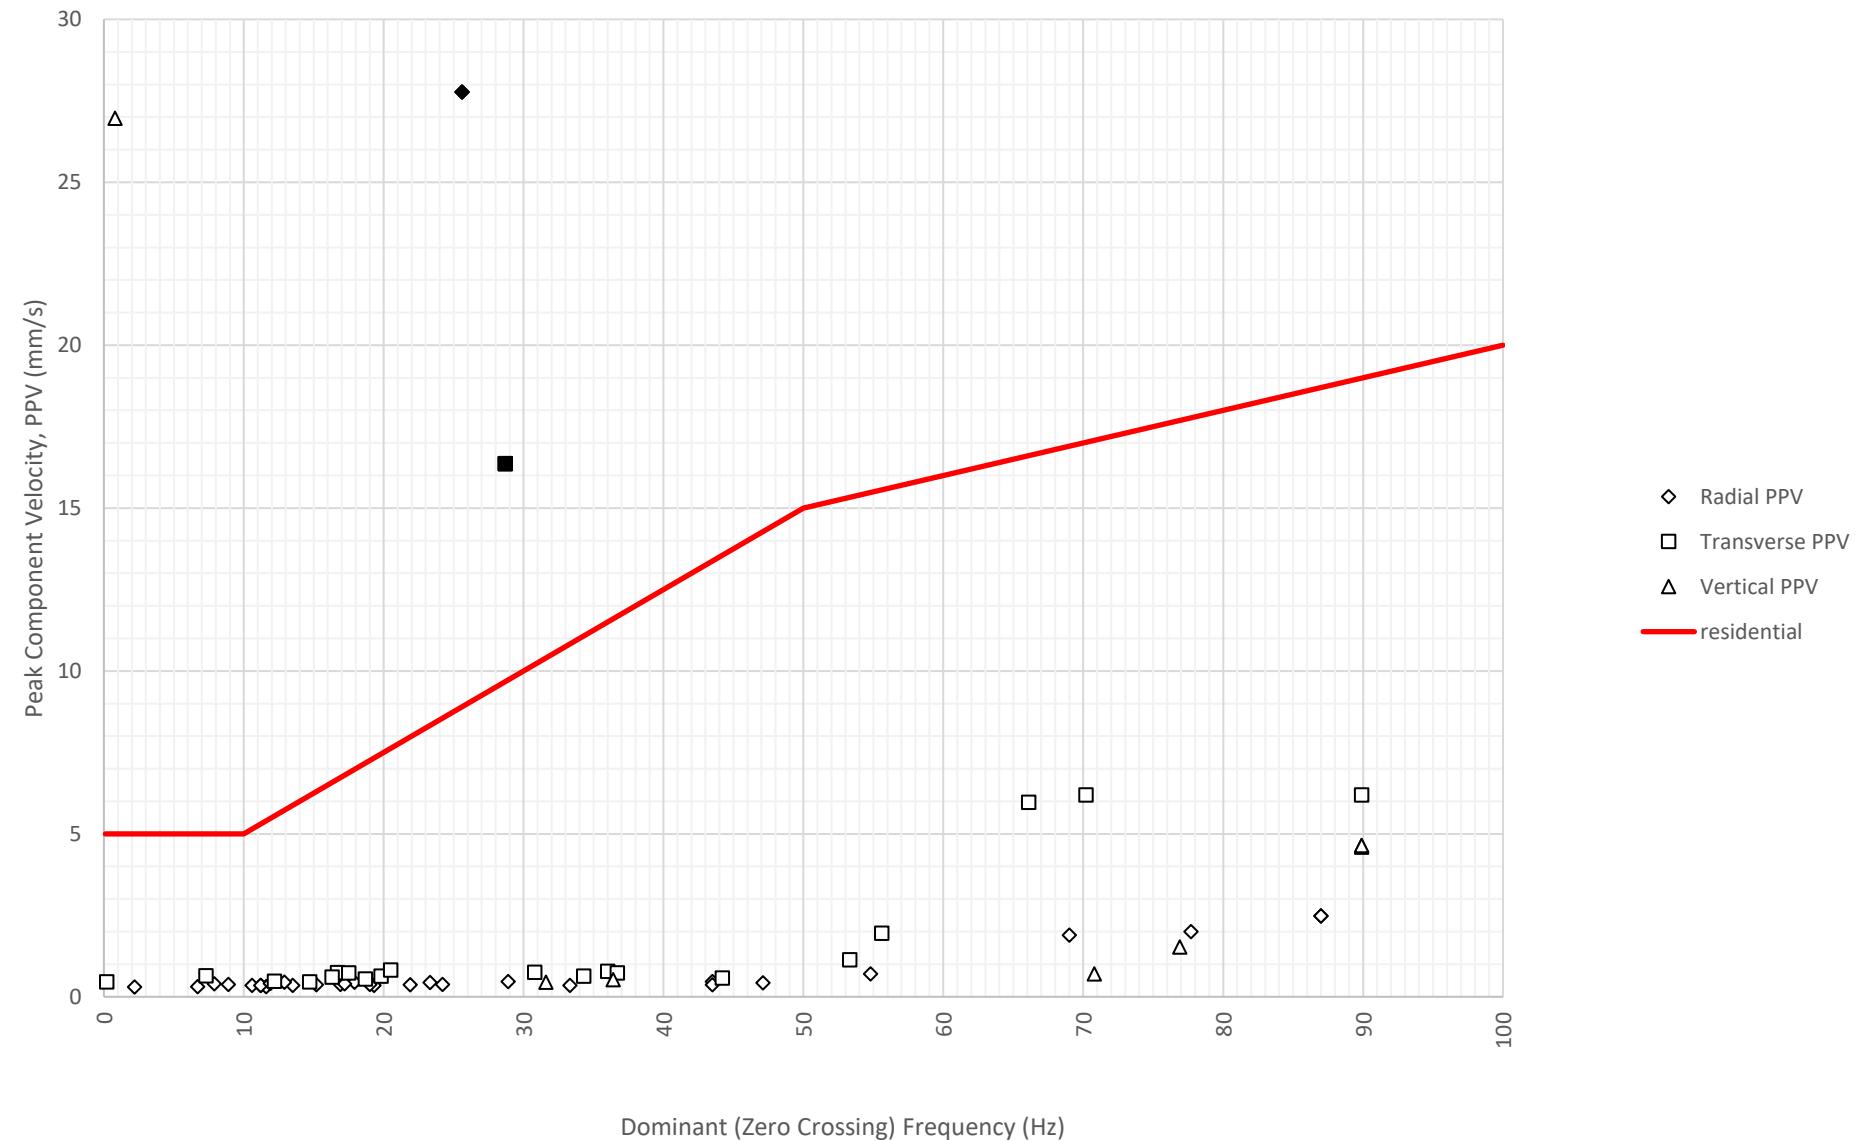
- 19th August 2022 9:00am to 9:30am.
- 22nd August 2022 between 7:00am to 7:30am.
- 24th August 2022 between 2:30pm to 3:00pm.

These isolated short-term exceedances were assessed with Taylor Construction and were due to demolition works being undertaken in the immediate location of monitor, which is offset from the residential property by approximately 5m. As a result, the localised demolition immediately adjacent to the monitor resulted in the artificial inflation of measured results. Notwithstanding, a visual inspection of the residential property is recommended, in addition to investigating the feasibility of relocating the monitor to the exact boundary of the residential premises. No other exceedances from the demolition works were measured for the rest of the monitoring period.

Daily Monitored Vibration Levels at M7715 on 24-08-2022

Frequency Content of Vibration Levels at M7715 on 24-08-2022
