## Roseville Anglican College Sports & Wellbeing Centre

### Noise and Vibration Monitoring Report 3

Project ID	20220917.5
Document Title	Noise and Vibration Monitoring Report 3
Attention To	Taylor Construction Group Pty Ltd

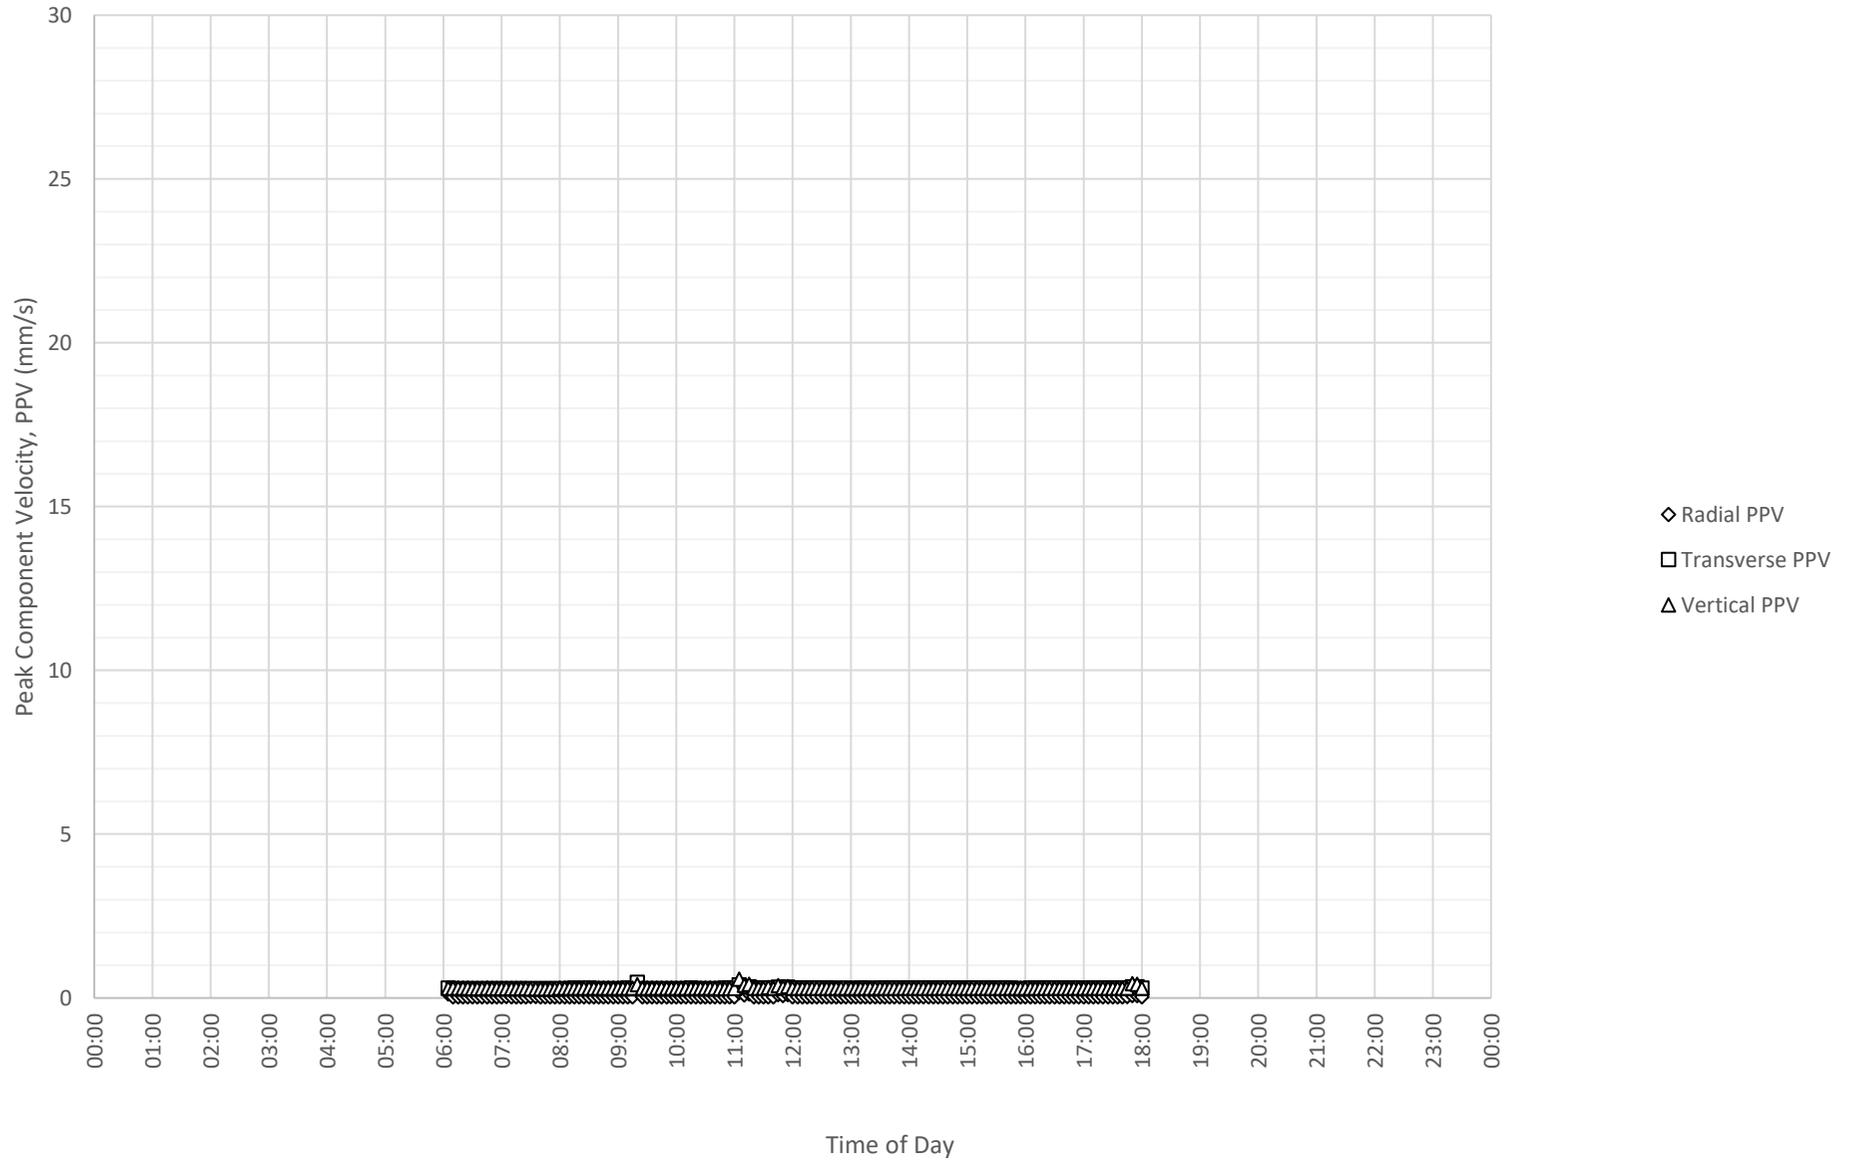
Daily Monitored Vibration Levels at M7713 Heritage (front) on 1-10-2022

Frequency Content of Vibration Levels at M7713 Heritage (front) on 1-10-2022

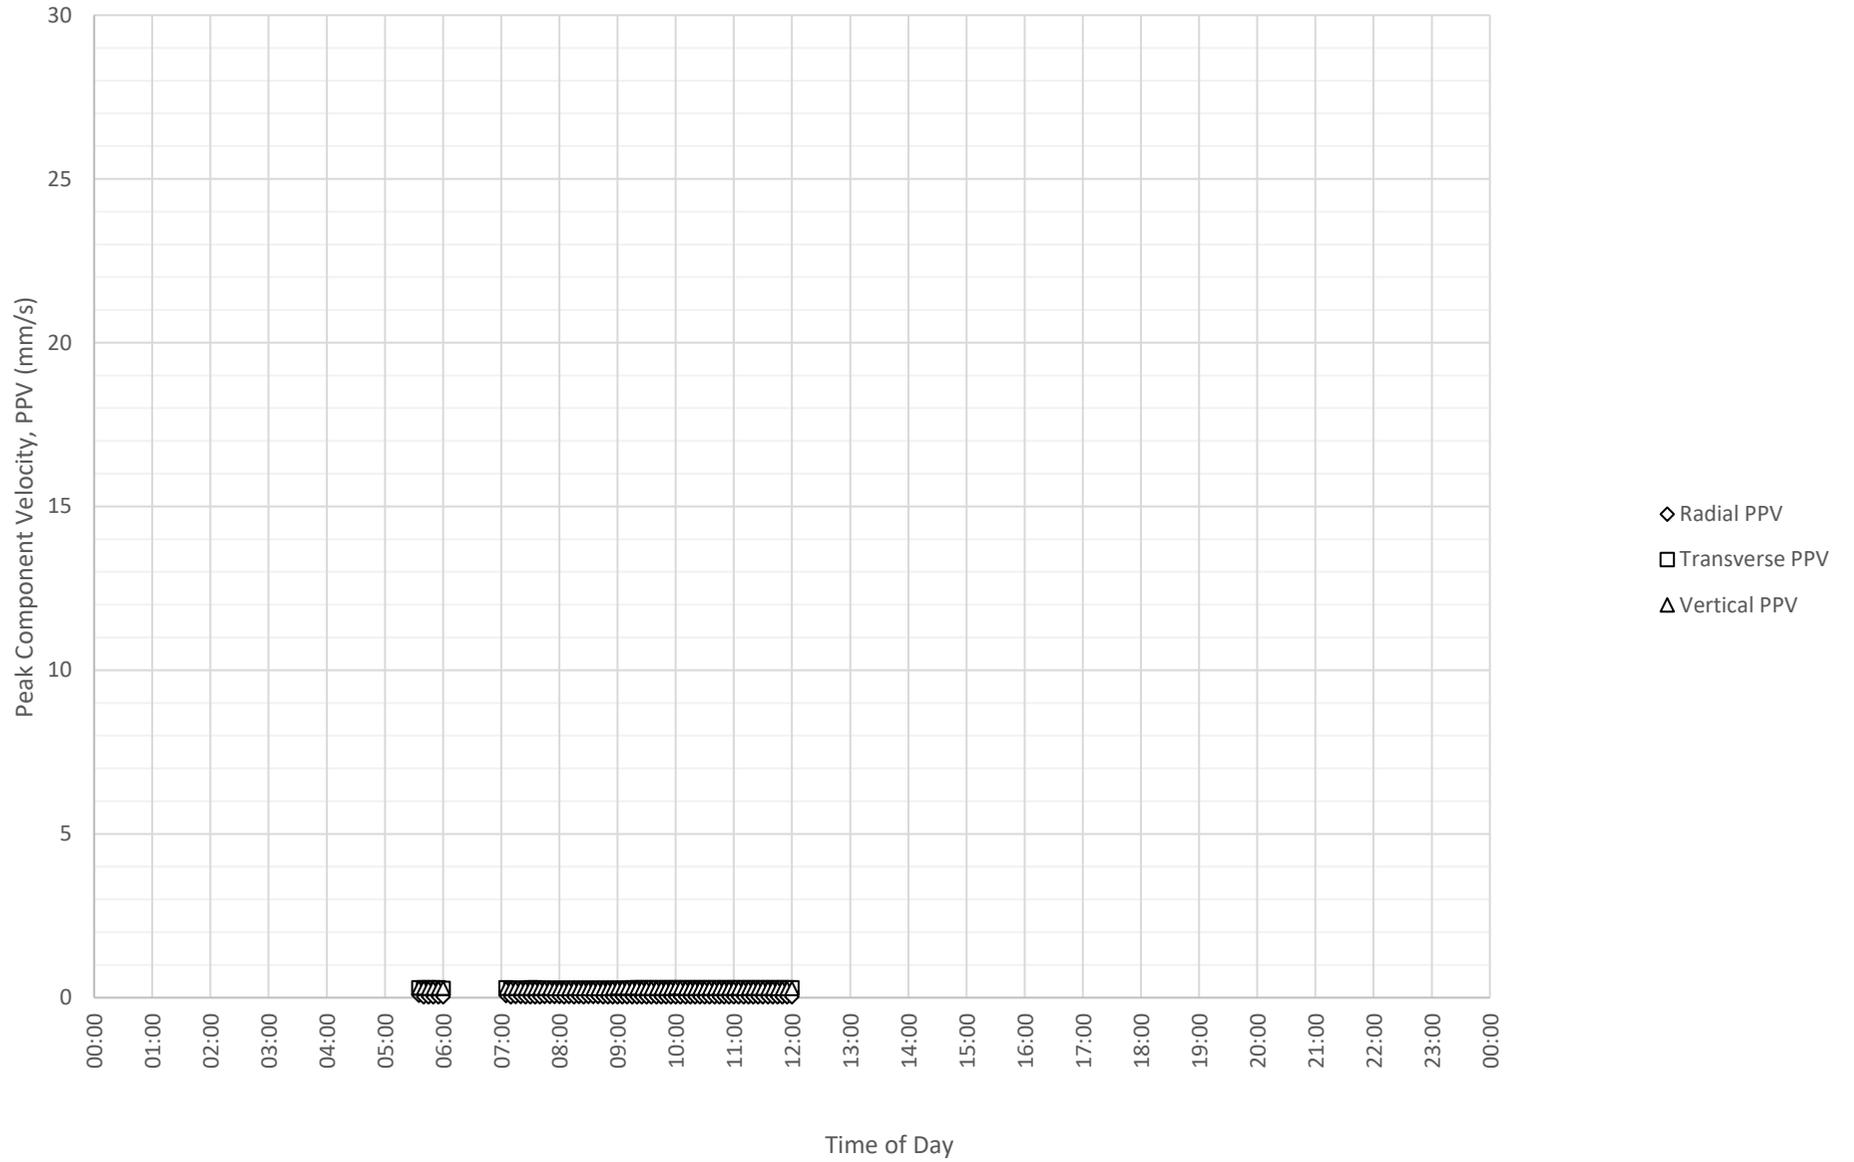
Daily Monitored Vibration Levels at M7713 Heritage (front) on 2-10-2022

Frequency Content of Vibration Levels at M7713 Heritage (front) on 2-10-2022

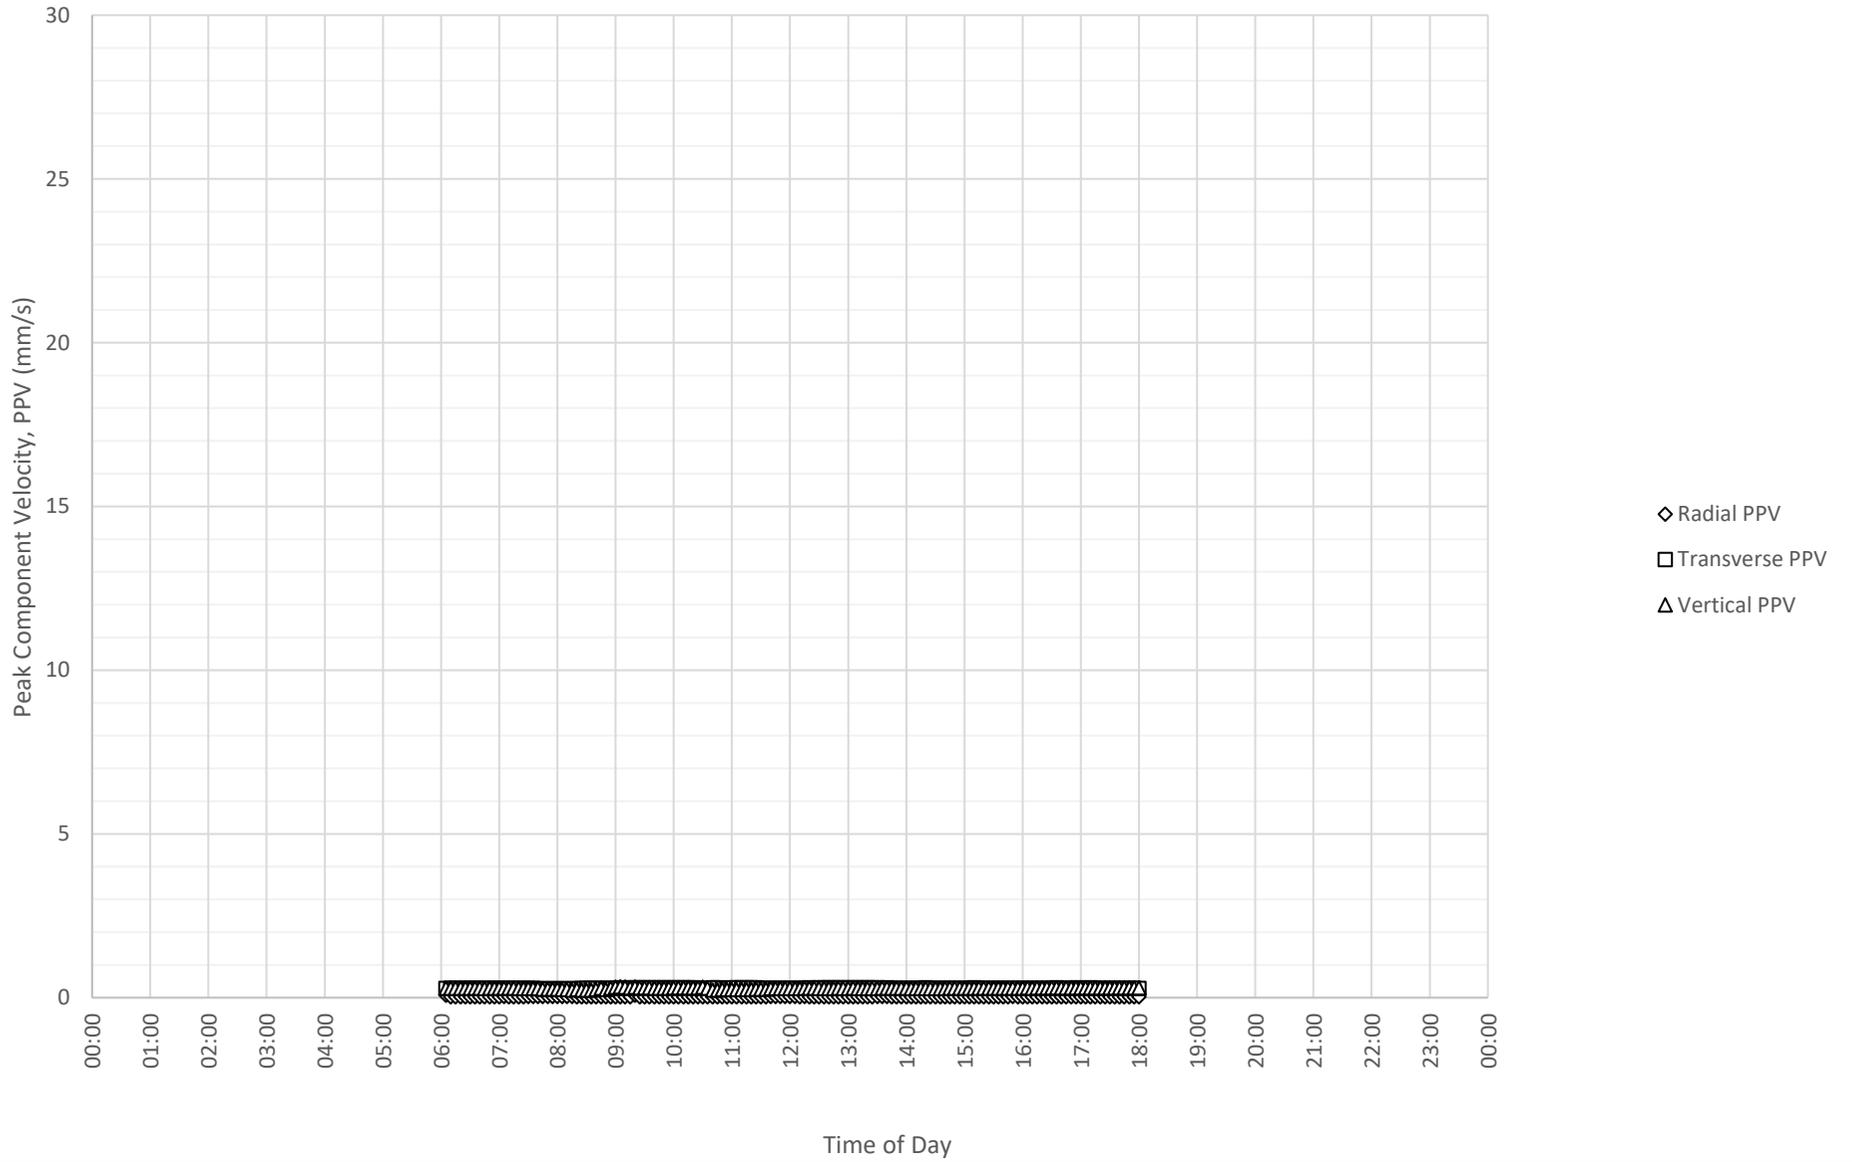
Daily Monitored Vibration Levels at M7713 Heritage (front) on 3-10-2022

Frequency Content of Vibration Levels at M7713 Heritage (front) on 3-10-2022

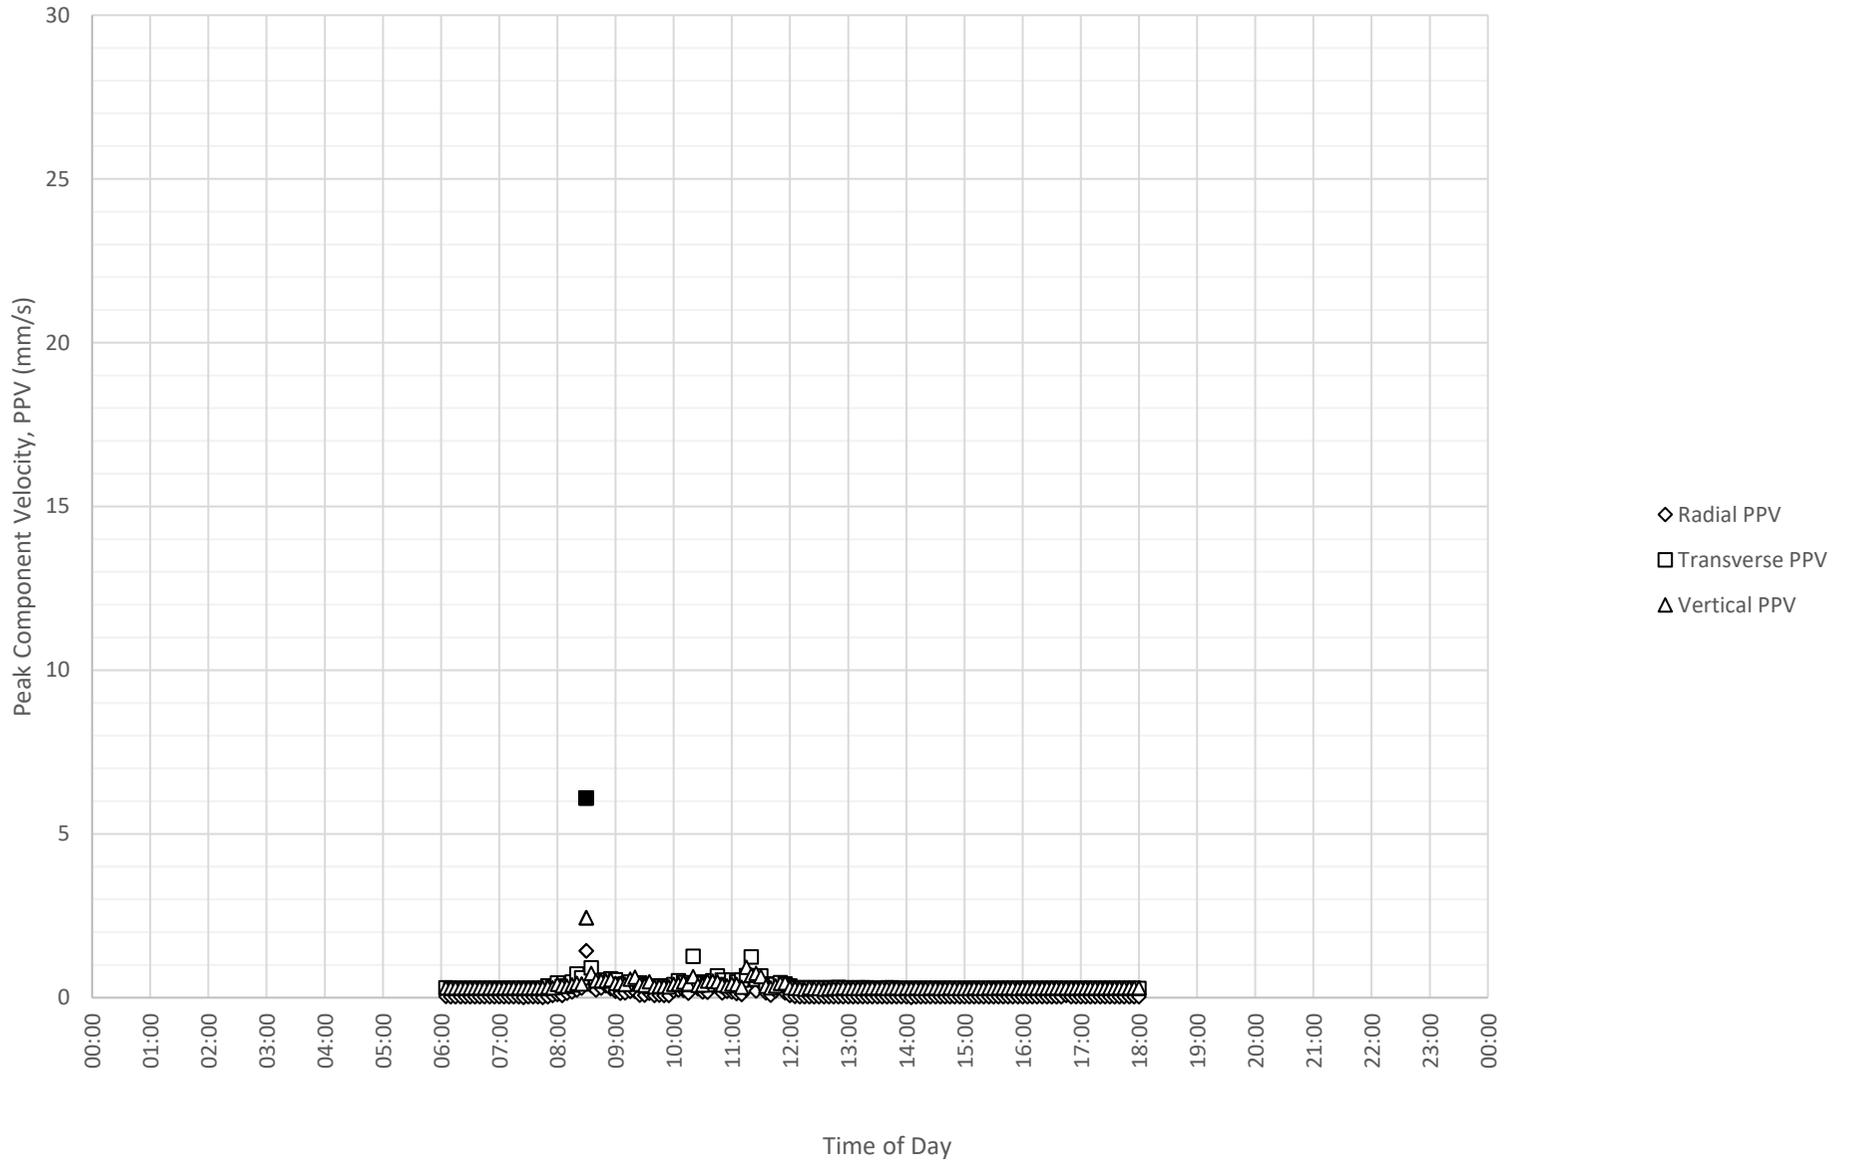
- M7427 did not measure any exceedances during this monitoring period.
- M7713 measured exceedances on the 15<sup>th</sup>, 21<sup>st</sup> and 28<sup>th</sup> October 2022. Project team was notified, and we were informed that piling works were being undertaken along the front of the heritage building. We note that the exceedances on the days mentioned above were a single event and not continuous. Upon receiving exceedance notification, construction methodologies were reviewed, and no further exceedance events were measured. For the rest of the monitoring period, measured vibration levels were below the DIN4150-03 criteria.

Daily Monitored Vibration Levels at M7713 Heritage (Front) on 15-10-2022

Frequency Content of Vibration Levels at M7713 Heritage (Front) on 15-10-2022

- In the event that continuous exceedances are notified via SMS notifications and the construction activities are identified, site practices are to be modified to prevent or mitigate to prevent the likelihood of recurrence.

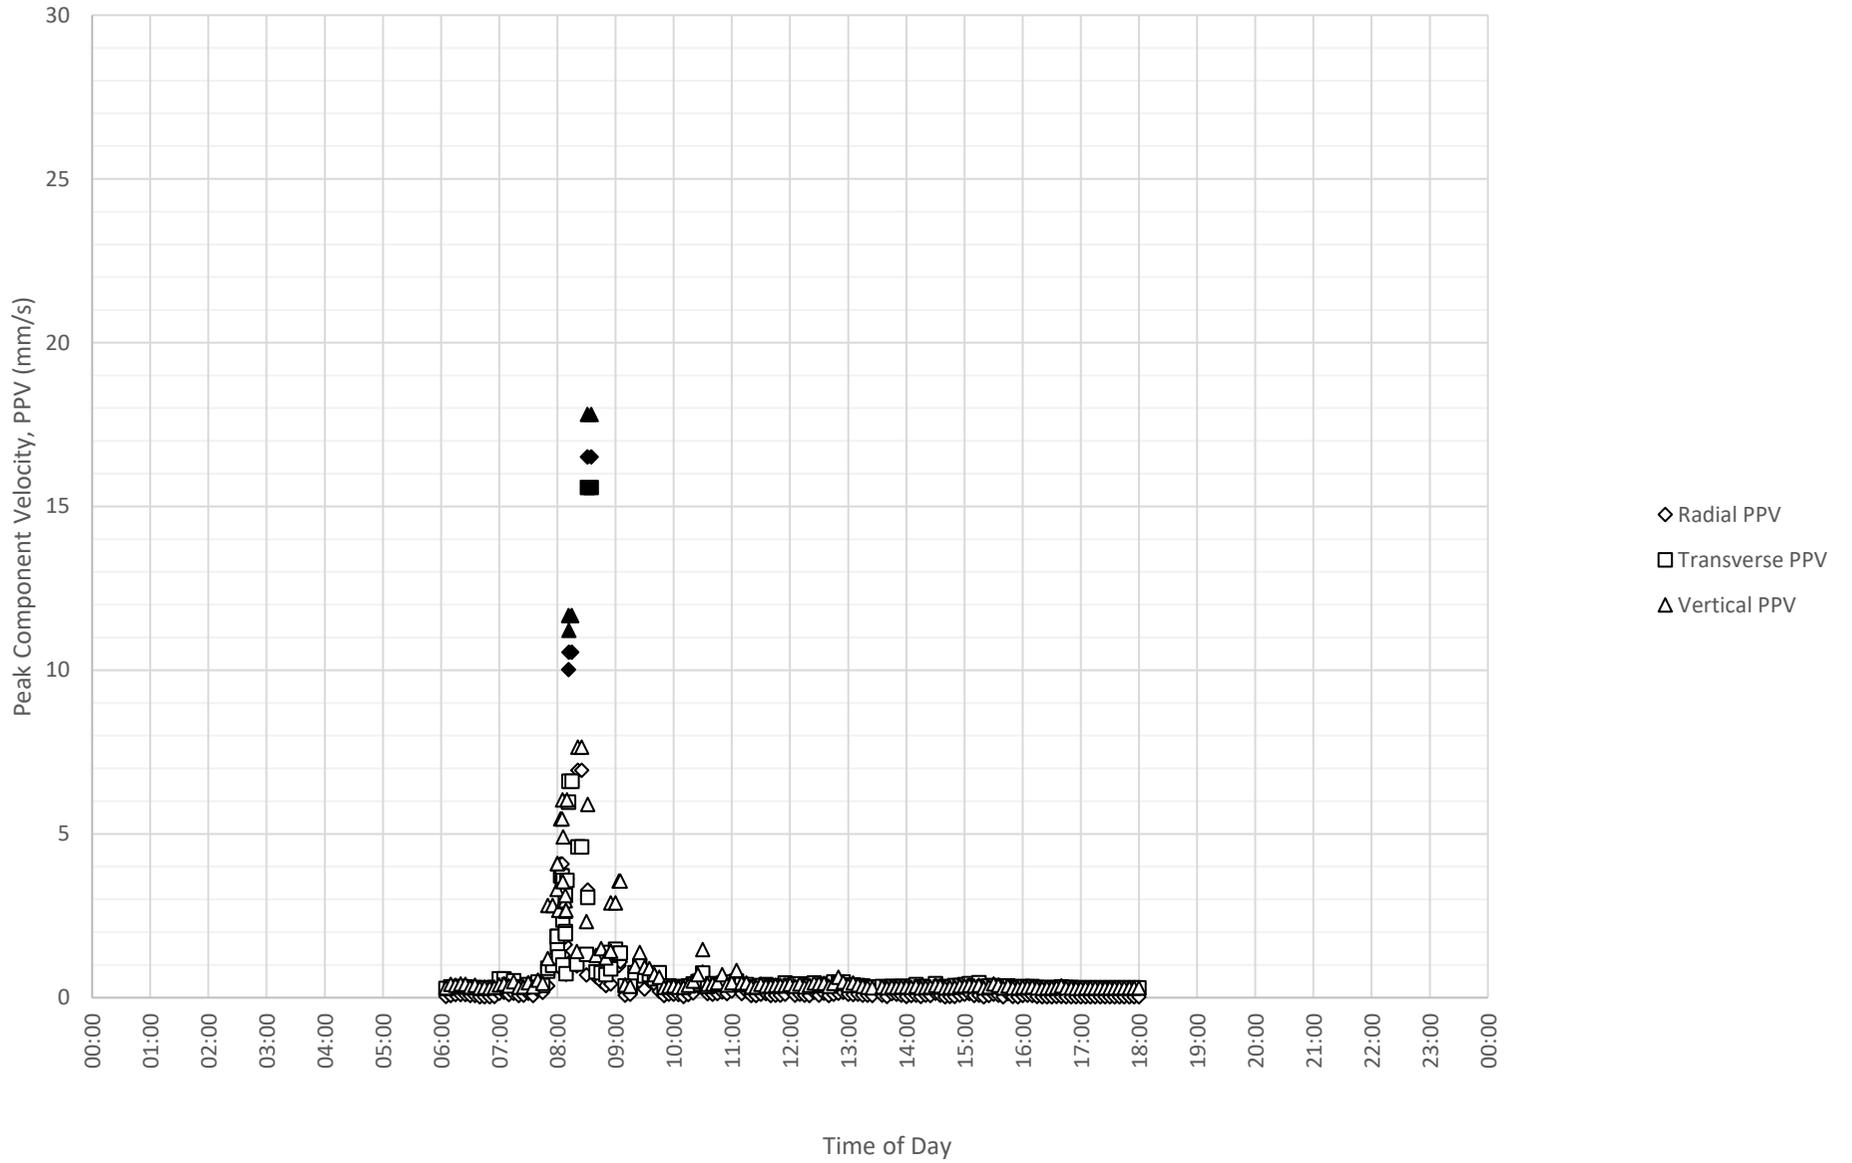
Daily Monitored Vibration Levels at M7713 Heritage (Front) on 21-10-2022

Frequency Content of Vibration Levels at M7713 Heritage (Front) on 21-10-2022

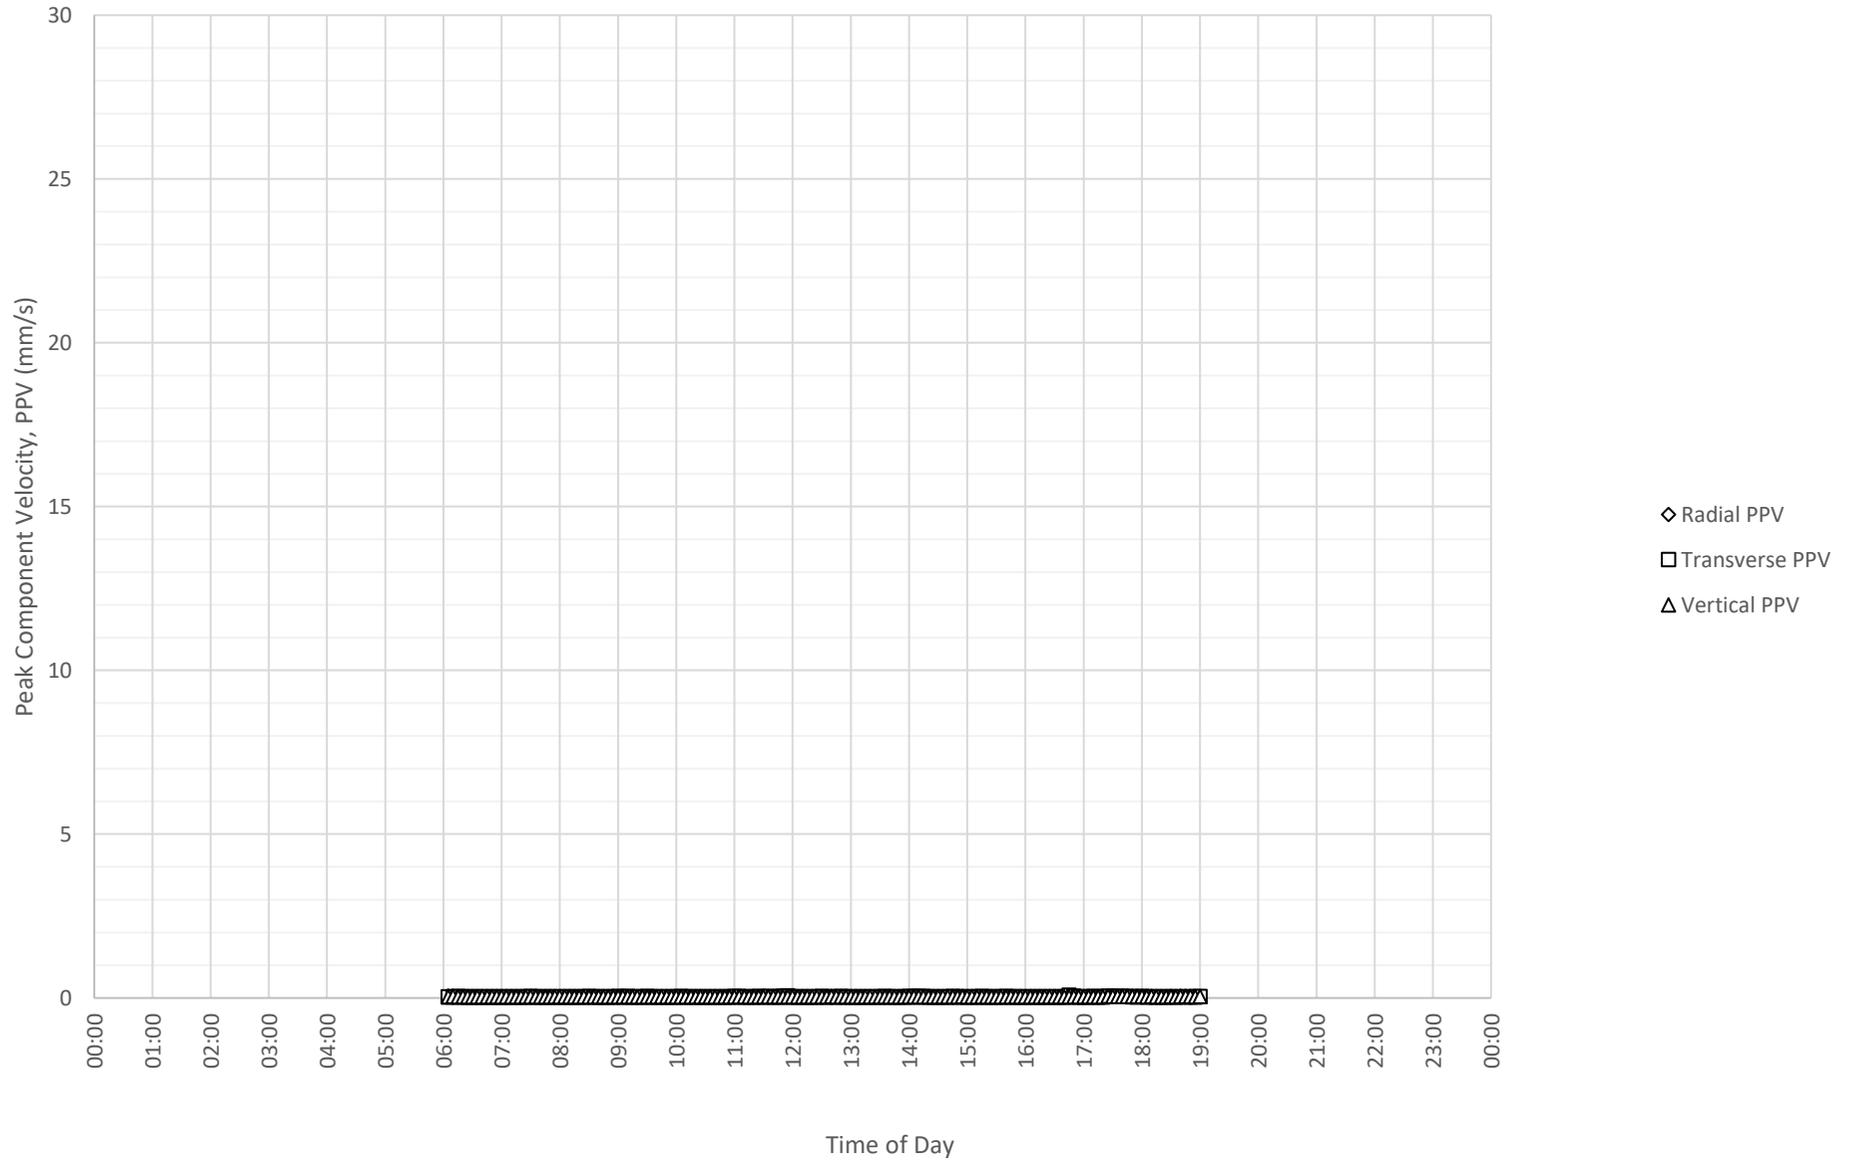
Daily Monitored Vibration Levels at M7427 Heritage (rear) on 1-10-2022

Frequency Content of Vibration Levels at M7427 Heritage (rear) on 1-10-2022

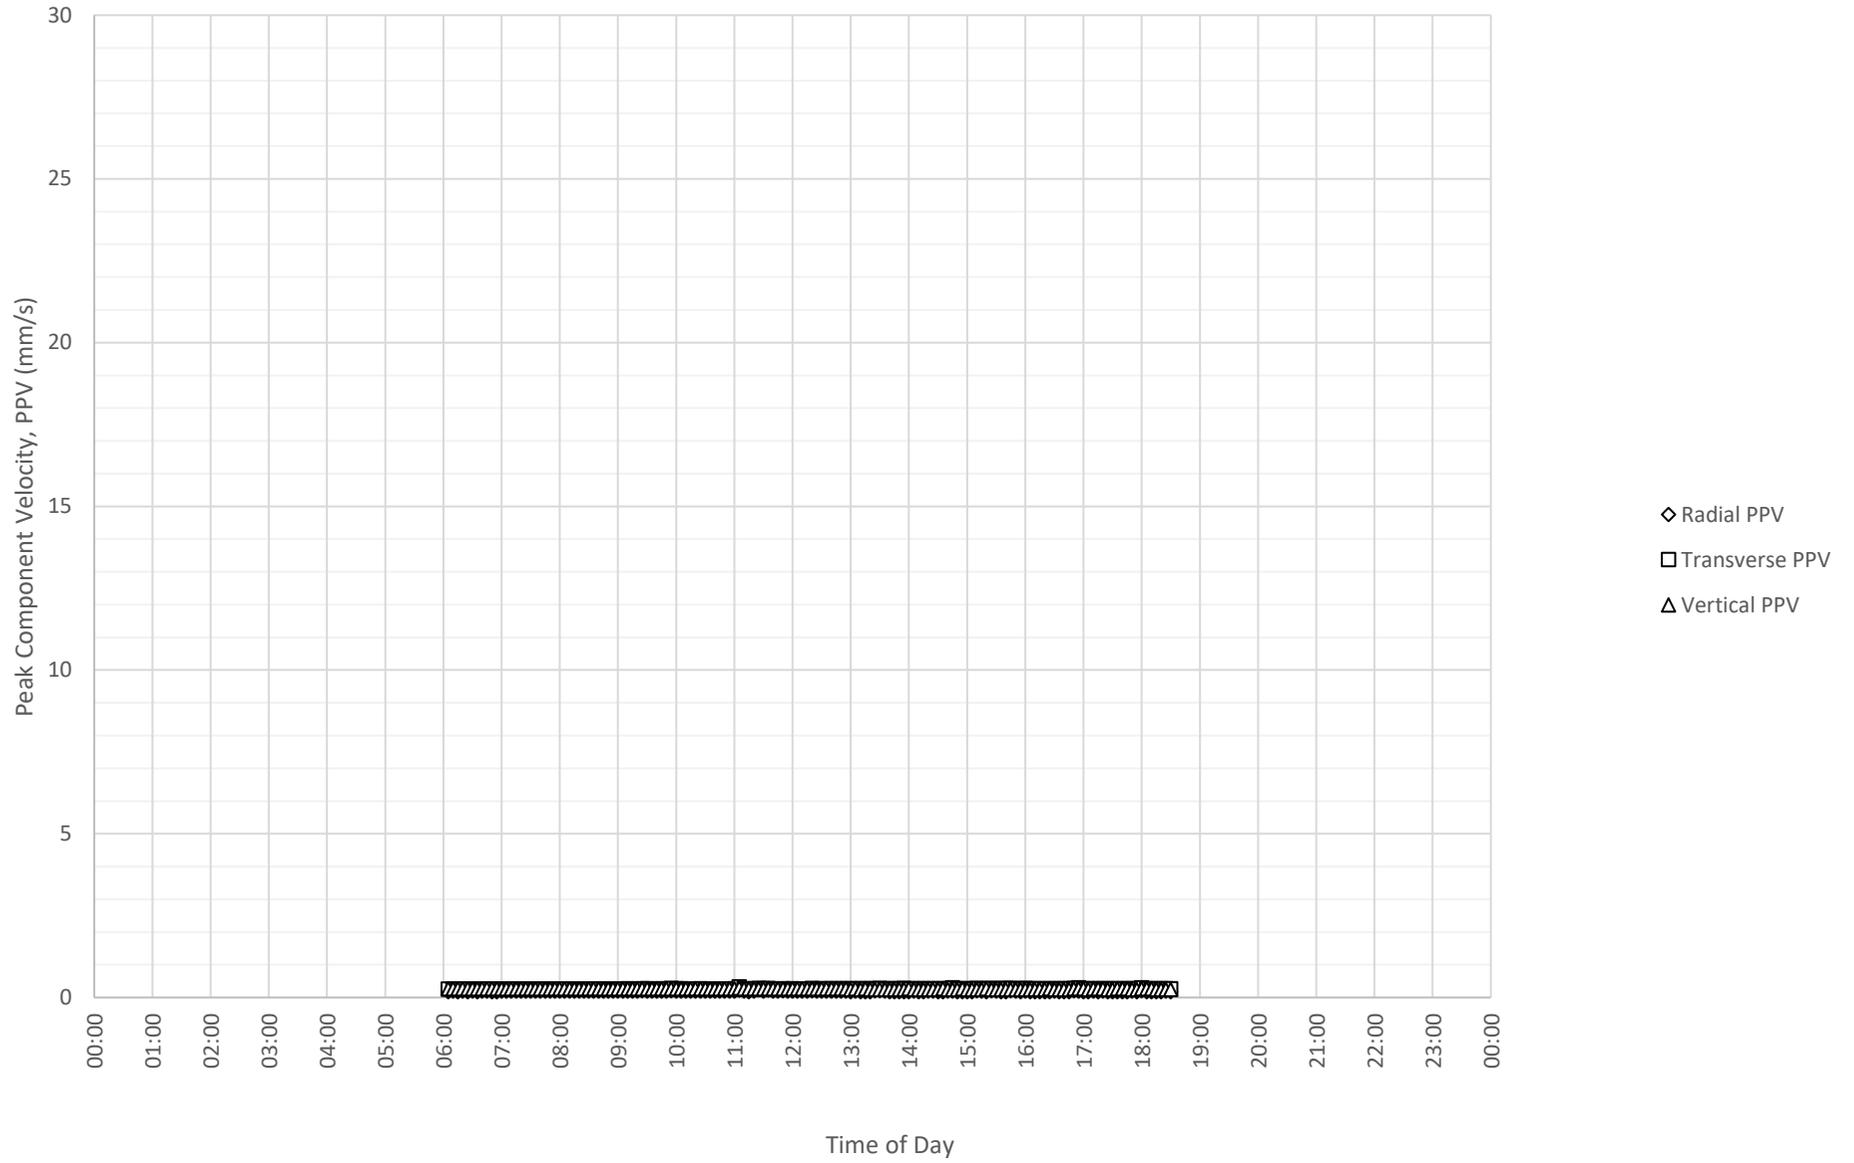
Daily Monitored Vibration Levels at M7715 Residential (east) on 1-10-2022

Frequency Content of Vibration Levels at M7715 Residential (east) on 1-10-2022

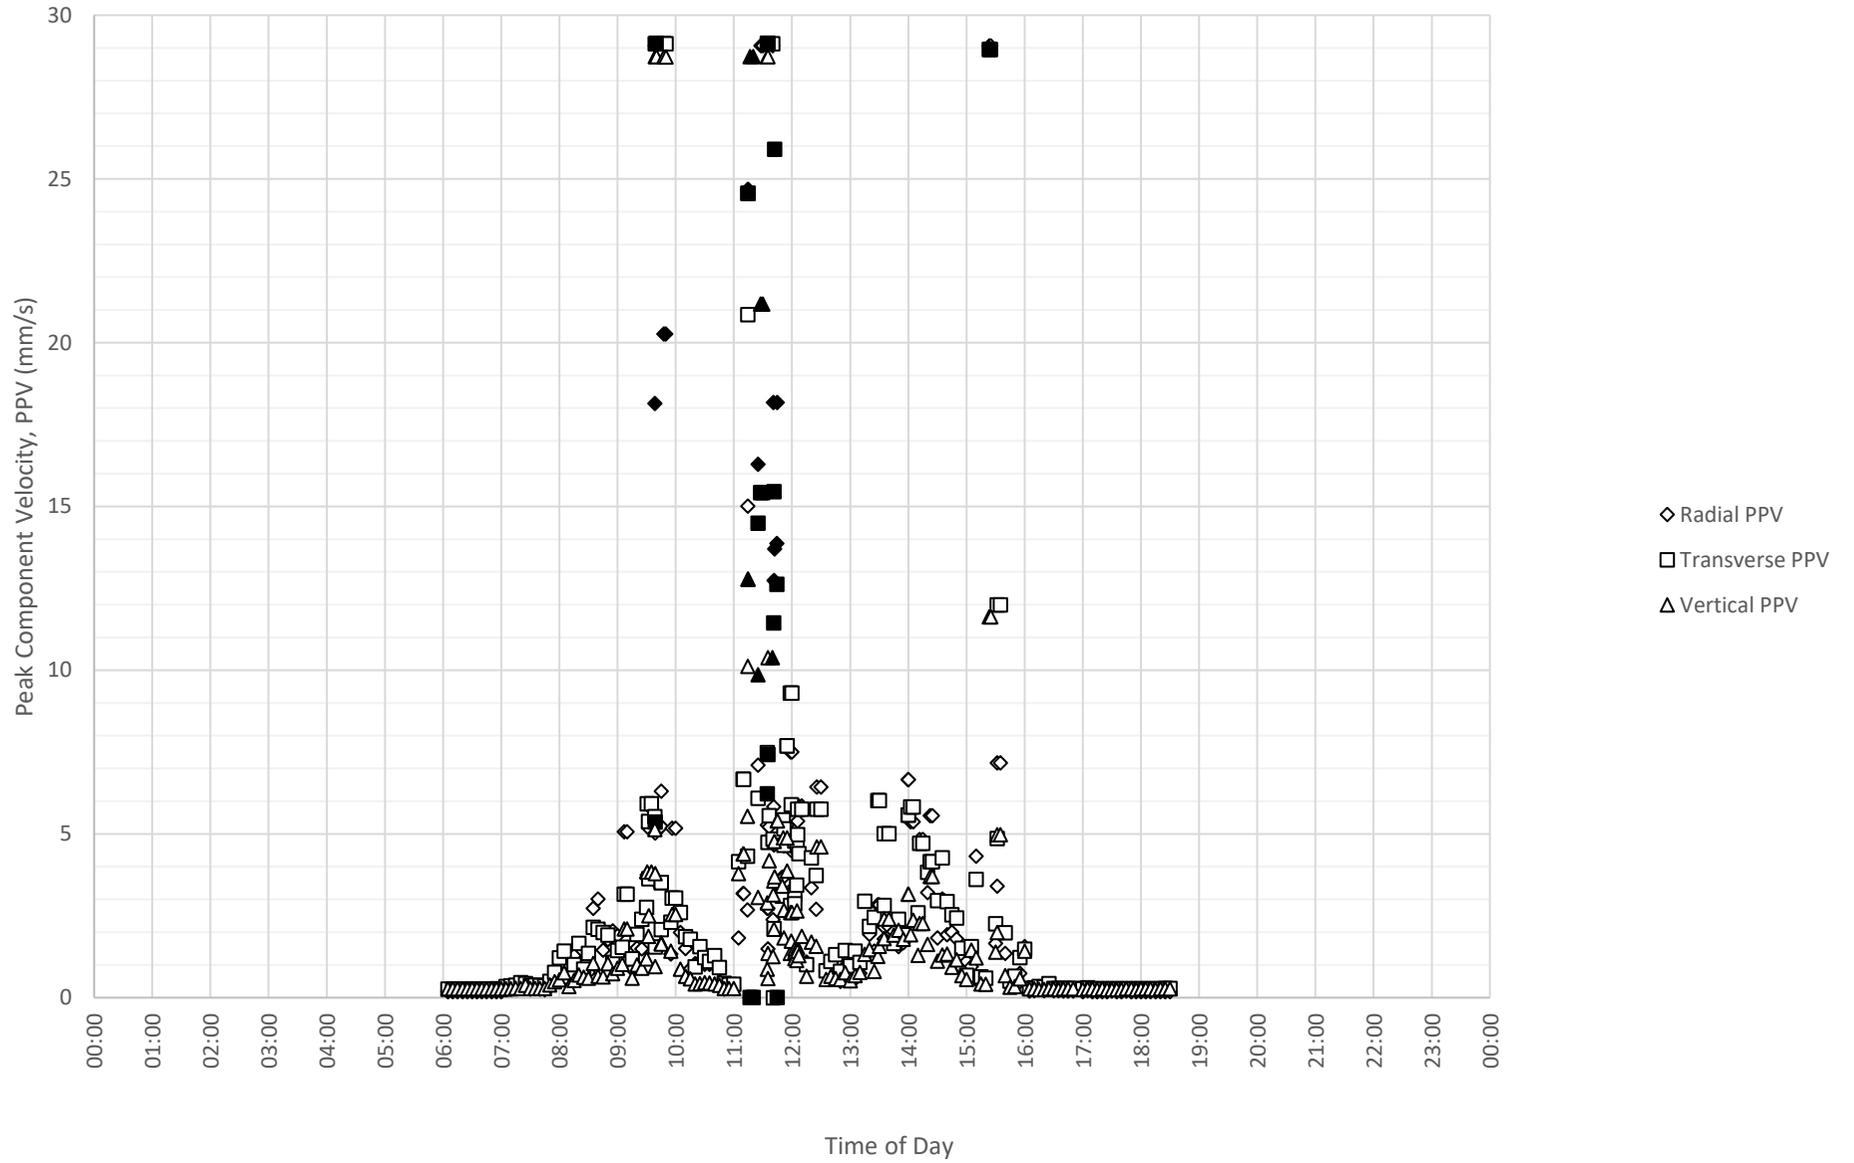
- M7715 measured exceedances on the 7<sup>th</sup> and 10<sup>th</sup> October 2022. Project team was notified, and we were informed that excavation and piling works were still being undertaken near to the geophone sensor along the residential receiver. Notwithstanding, due to the proximity of works to the monitor, the vibration levels to the nearest residential receiver should be less than the measured levels.

Daily Monitored Vibration Levels at M7715 Residential on 10-10-2022

Frequency Content of Vibration Levels at M7715 Residential on 10-10-2022
