**INDEPENDENT  
ENVIRONMENTAL AUDIT  
REPORT**

27-29 and 37 Bancroft Avenue, Roseville

The Anglican Schools Corporation  
23 May 2023

AU122160 R2

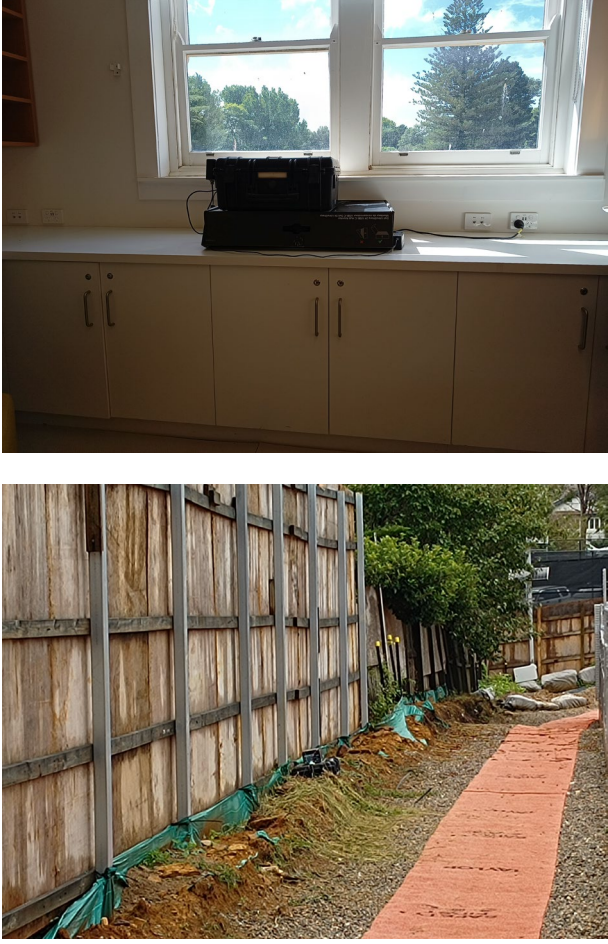
<p>Photo Number: G81</p>	<p>Date: 3/4/2023</p>

<p>Description: Vibration monitors</p>

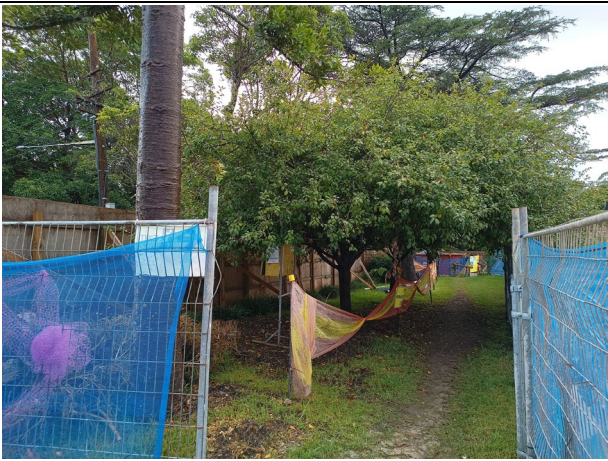
<p>Photo Number: G85</p>	<p>Date: 3/4/2023</p>

<p>Description: Tree protection zone was appropriately fenced off.  Protection was observed on trees on the footpath.</p>

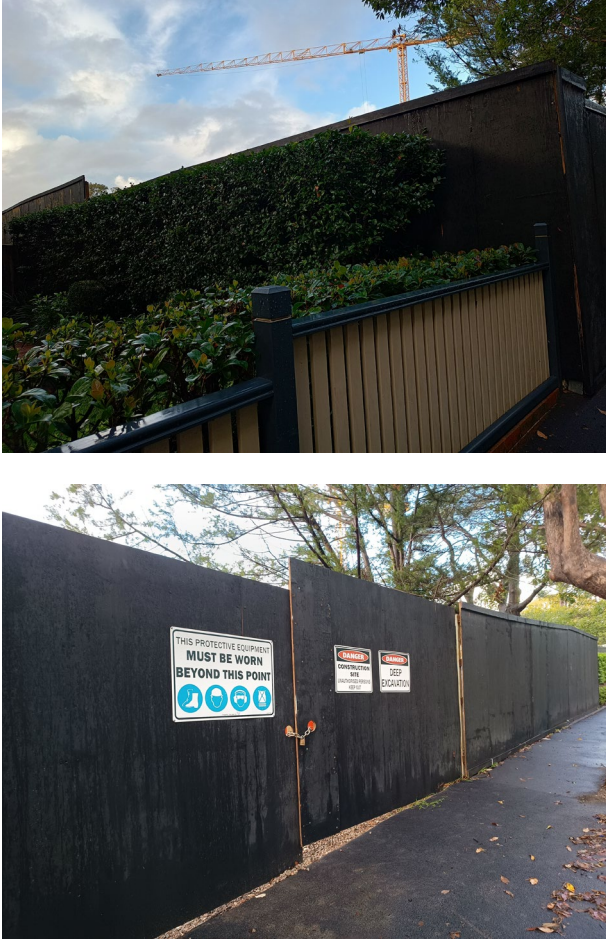
<p>Photo Number: G146, G191</p>	<p>Date: 3/4/2023</p>

<p>Description:  Hoarding observed along Bancroft Avenue and along eastern boundary.</p>

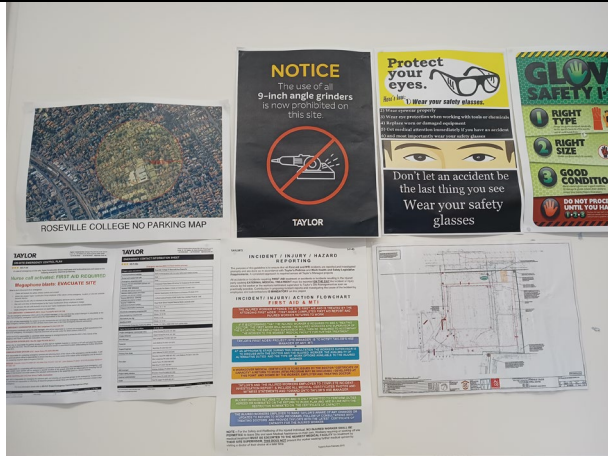
<p>Photo Number: G181</p>	<p>Date: 3/4/2023</p>

<p>Description: Emergency posters were observed in the site office.</p>

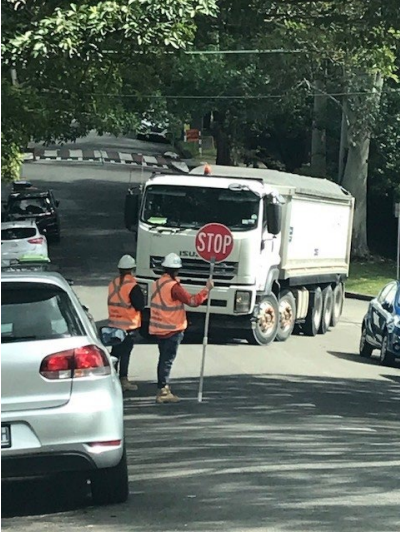
<p>Photo Number:  G89, G156, G188, G190</p>	<p>Date:  3/4/2023</p>

<p>Description:</p> <p>The truck was observed to have loads covered.</p> <p>Traffic controllers were observed on-site during the audit.</p>
