Roseville Anglican College Sports & Wellbeing Centre

Noise and Vibration Monitoring Report 2

Project ID	20220917.5
Document Title	Noise and Vibration Monitoring Report 2
Attention To	Taylor Construction Group Pty Ltd

This report covers the monitoring period between Wednesday 31st August 2022 to Friday 30th September 2022.

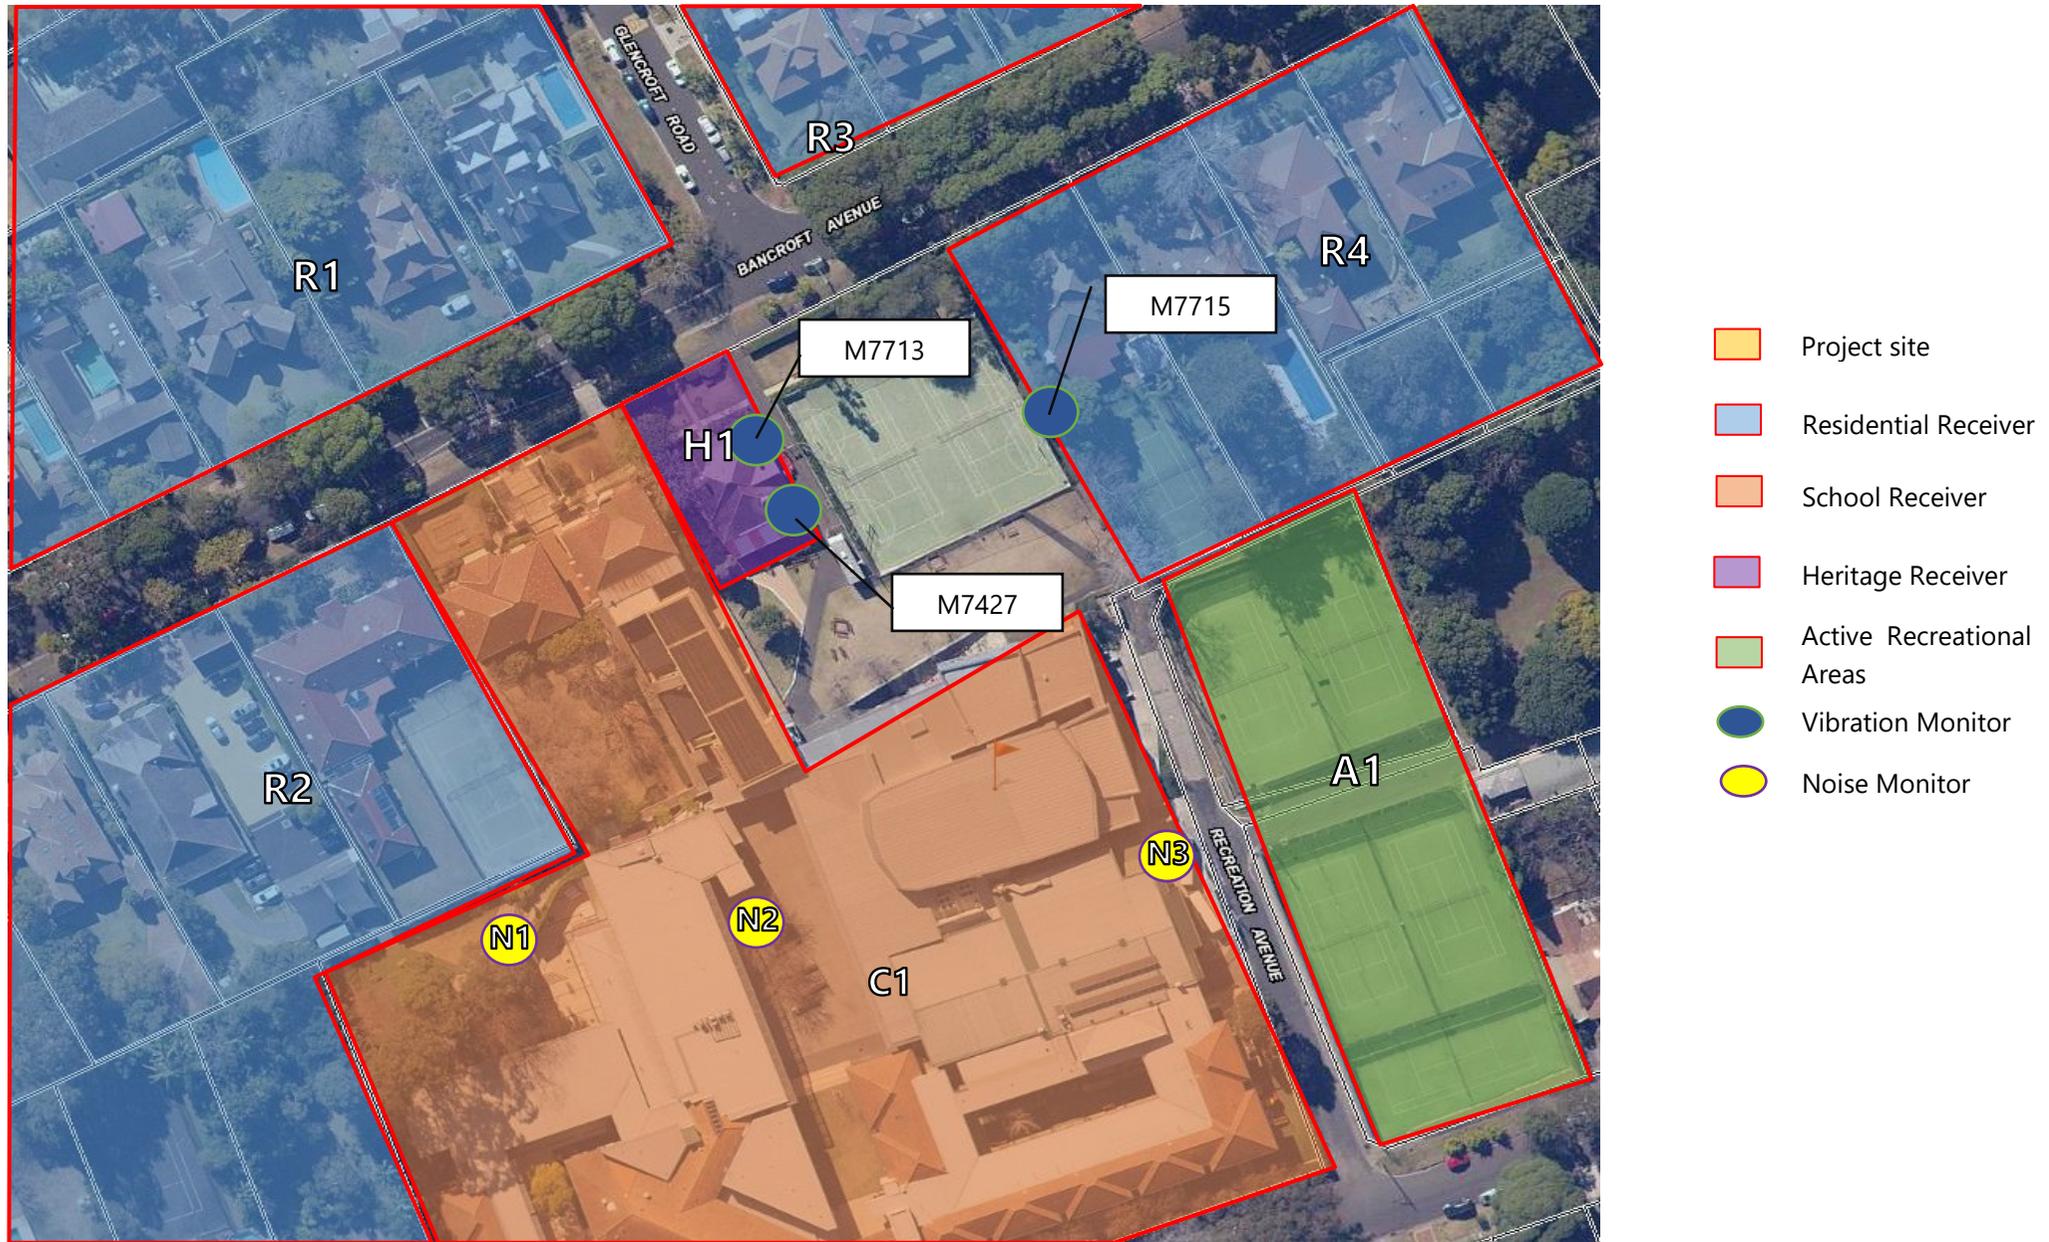
Figure 1: Aerial view of the project site and the sensitive receivers (Sourced : SixMaps)

The project site is surrounded by existing residential dwellings as well as existing commercial buildings of Roseville College. Refer to Figure 1 for the arial view of the project site and locations of vibration monitors.

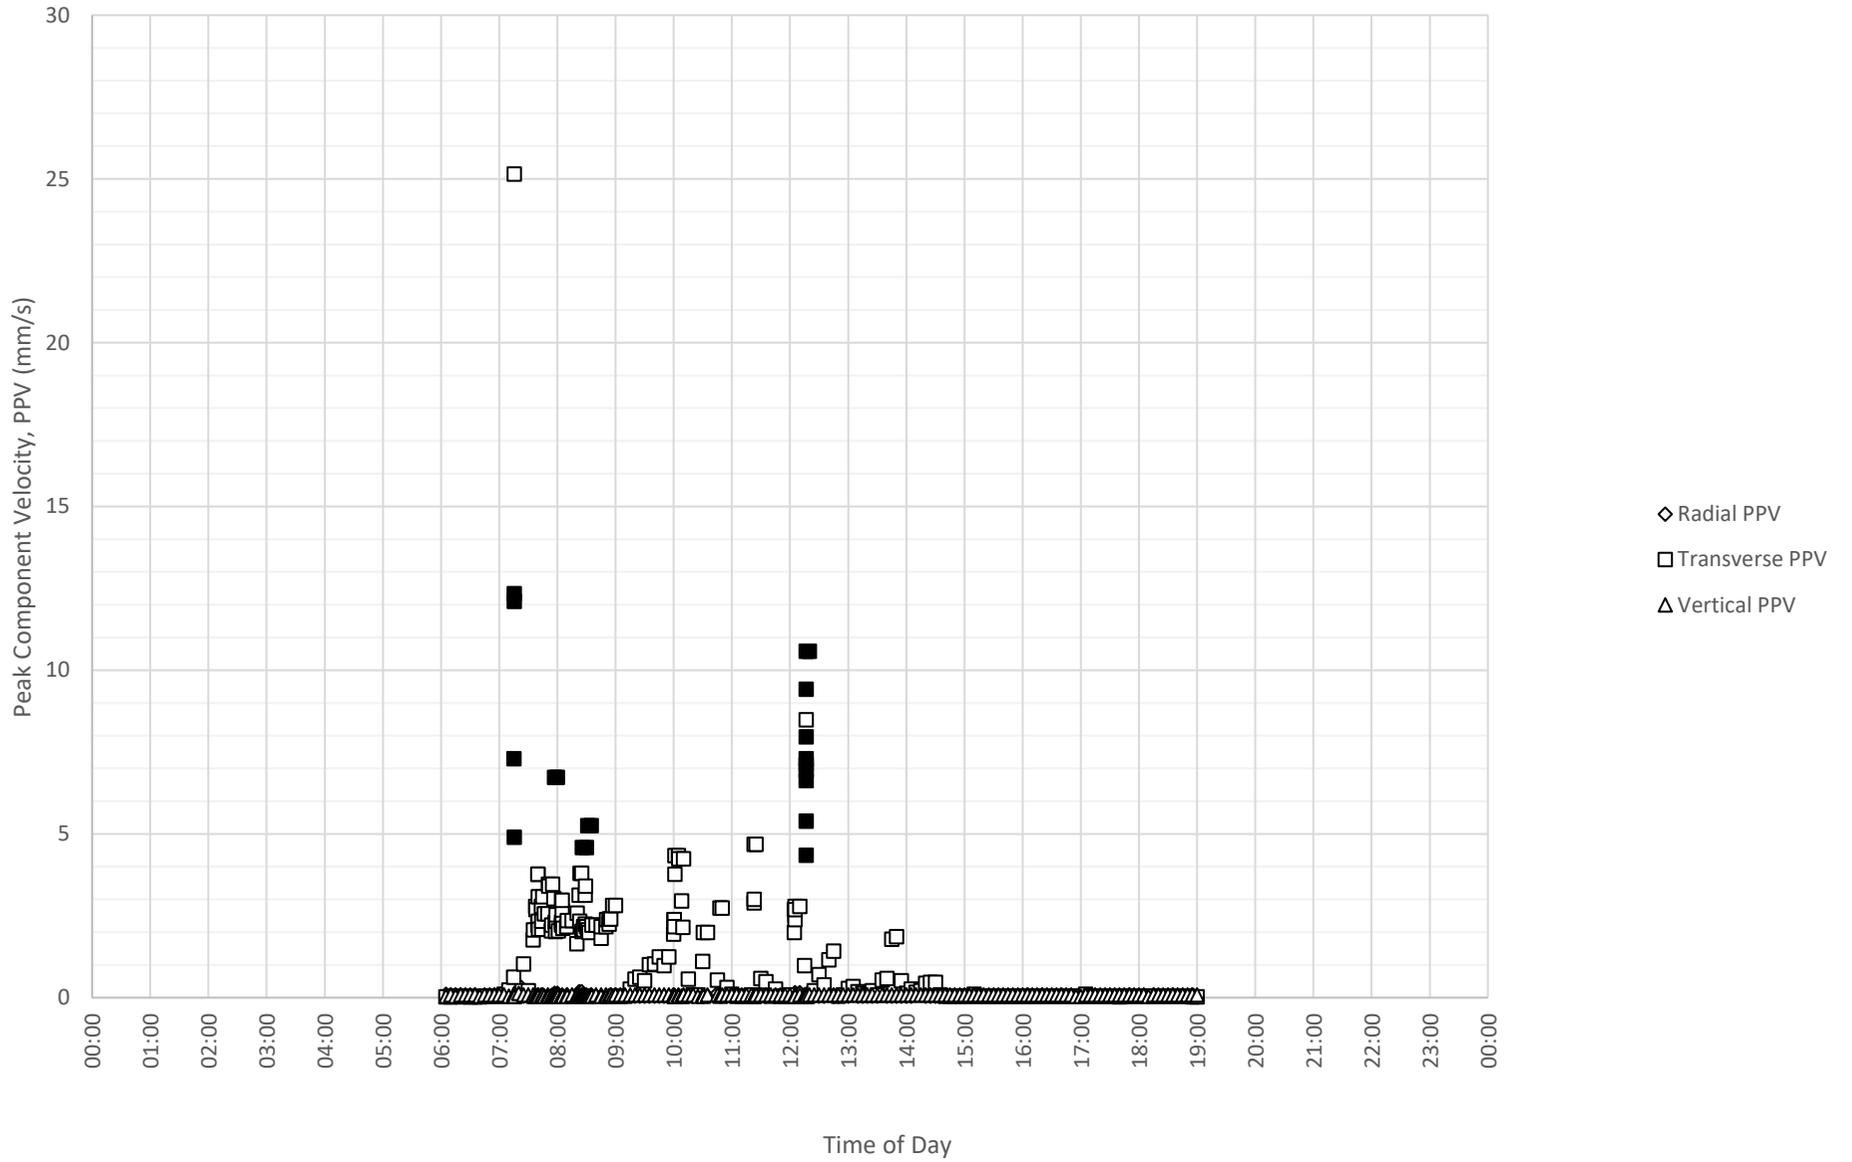
Daily Monitored Vibration Levels at M7713 Heritage (front) on 2-09-2022

- Exceedances was measured on the 2nd and 13th September 2022 on the front of the heritage building. Acoustic Logic was notified that drilling occurred in close proximity to the monitor, in order to complete required concreting works to support the building prior to piling works. After the foundation support was completed, the vibration levels were returned to normal levels.

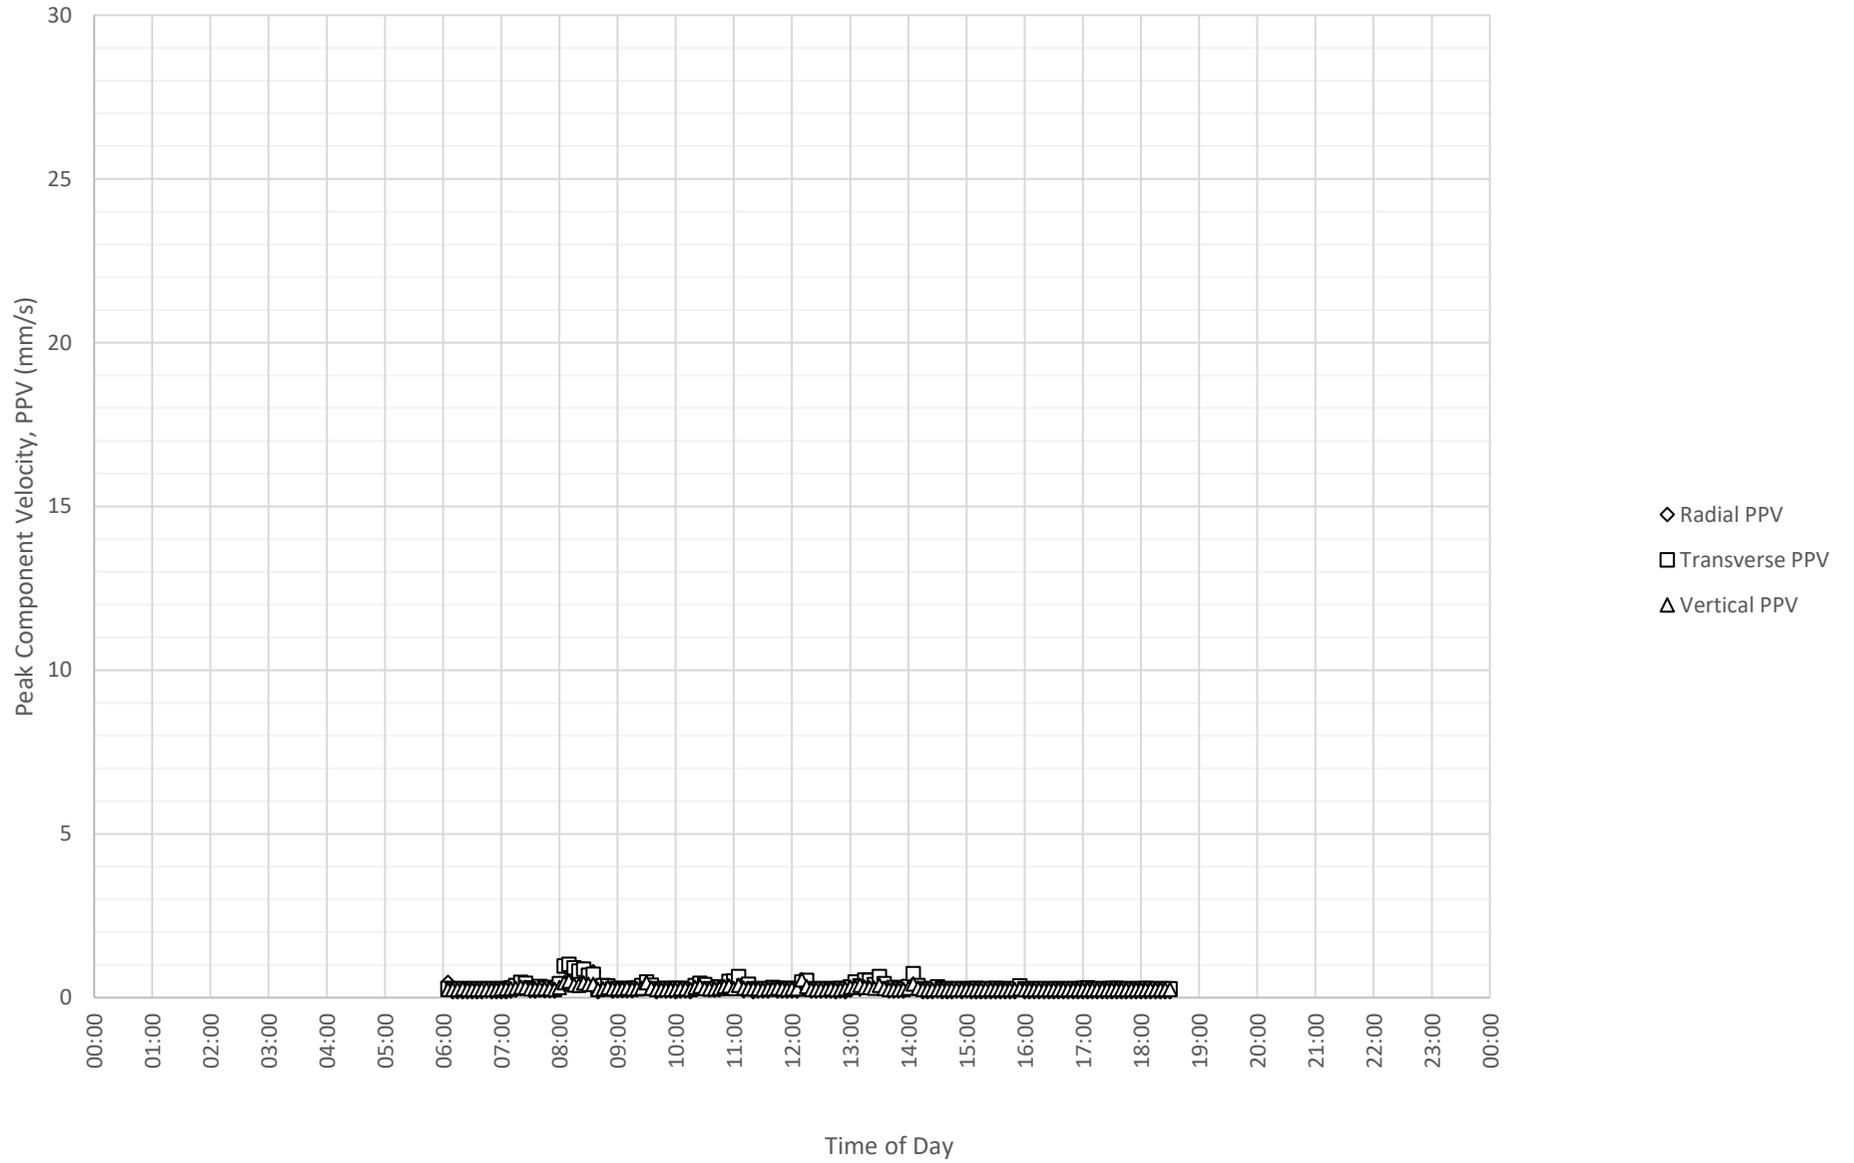
Daily Monitored Vibration Levels at M7715 Residential (east) on 12-09-2022

- Excavator works were being undertaken in close proximity to M7715 located adjacent to the residential boundary. Event exceedances was measured on the 12th September to 21st September 2022 due to the proximity of piling works to the monitor. Vibration levels to the nearest residence receiver should be less than the measured levels.

- In the event that continuous exceedances are notified via SMS notifications and the construction activities are identified, site practices are to be modified to prevent or mitigate to prevent the likelihood of recurrence.
