Construction Environmental Management Plan (CEMP)

Roseville College

27 Bancroft Avenue Roseville

E-PLAN-03 (October 2021) | Approved by Andrew Andreou
Uncontrolled copy once printed.

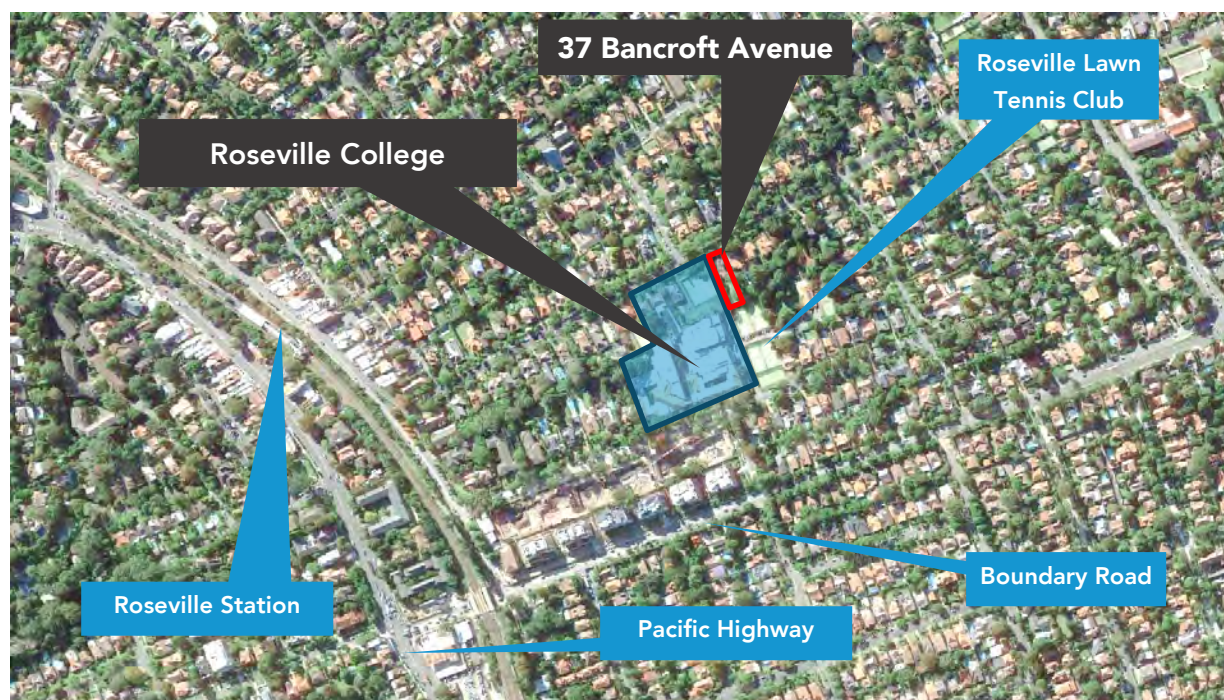
Figure 2-1 – Roseville College Context

The aerial photograph in Figure 2-1 provides an overview of the area and context in relation to the surrounding land uses.

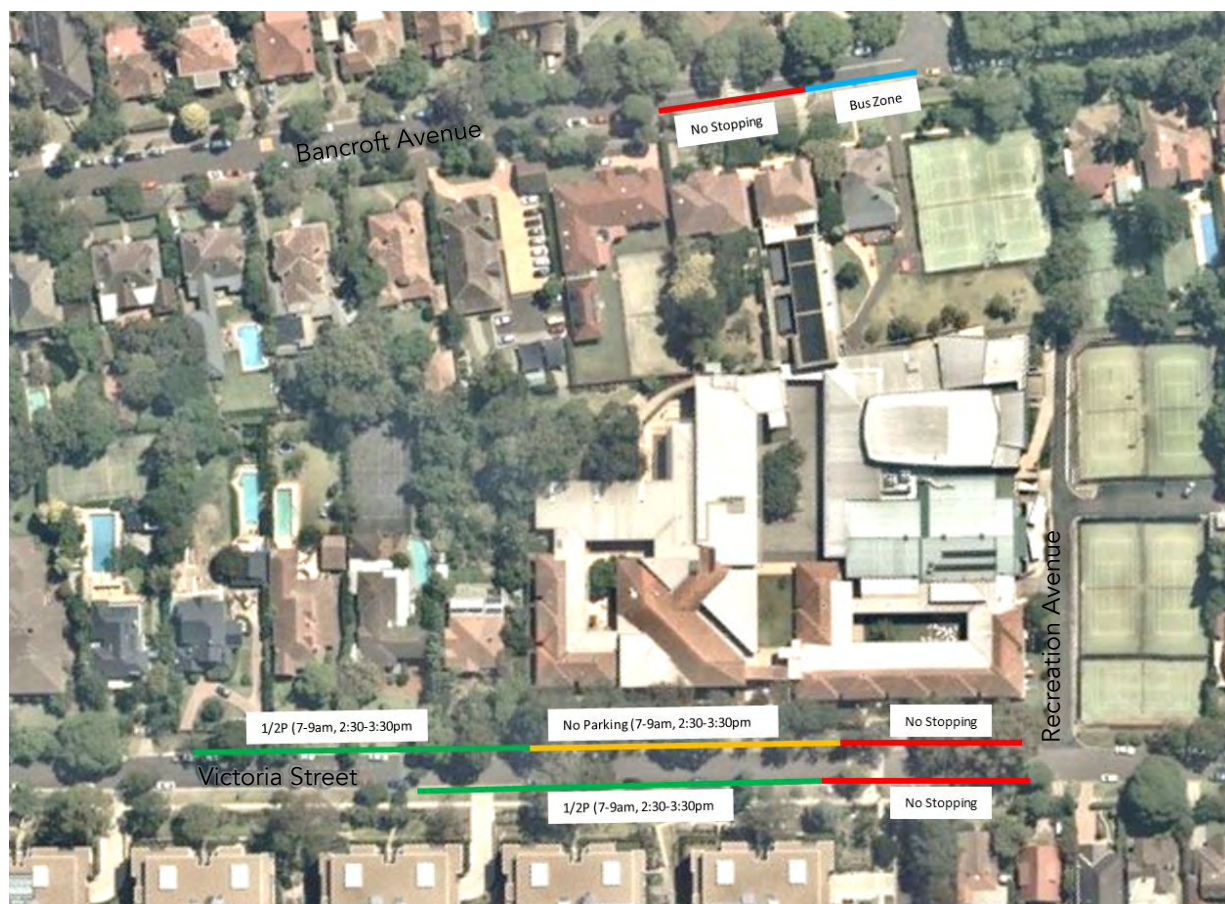
Figure 3-2 – Existing On-Street Parking Controls

The College has two road frontages; Victoria Street and Bancroft Avenue with on-street parking. The on-street parking restrictions vary subject to different time of day. The various parking controls are presented in Figure 3-2 which comprise either unrestricted parking, 'No Parking', or 'No Parking during student drop-off and pick-up periods' ('No Parking' permits a driver to stop for up to two minutes, however, they must remain within three metres of the vehicle) and 1/2P during school pickup and drop-off periods. The on-street drop-off parking will need to be relocated to accommodate the Works Zone.

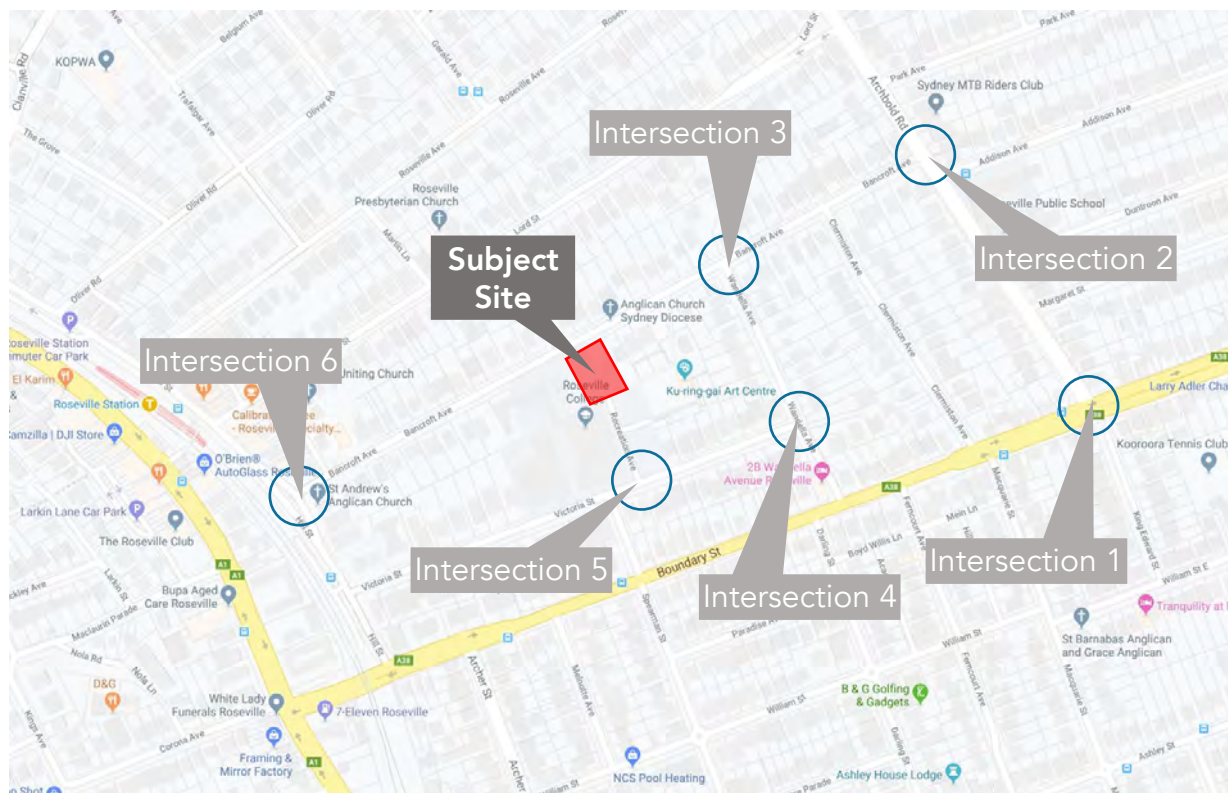
Figure 4-3 – Intersection Overview

Swept path analysis has been undertaken utilising a truck and dog truck being the largest expected vehicle type on the key intersections to confirm that the exiting intersections can accommodate these vehicles.

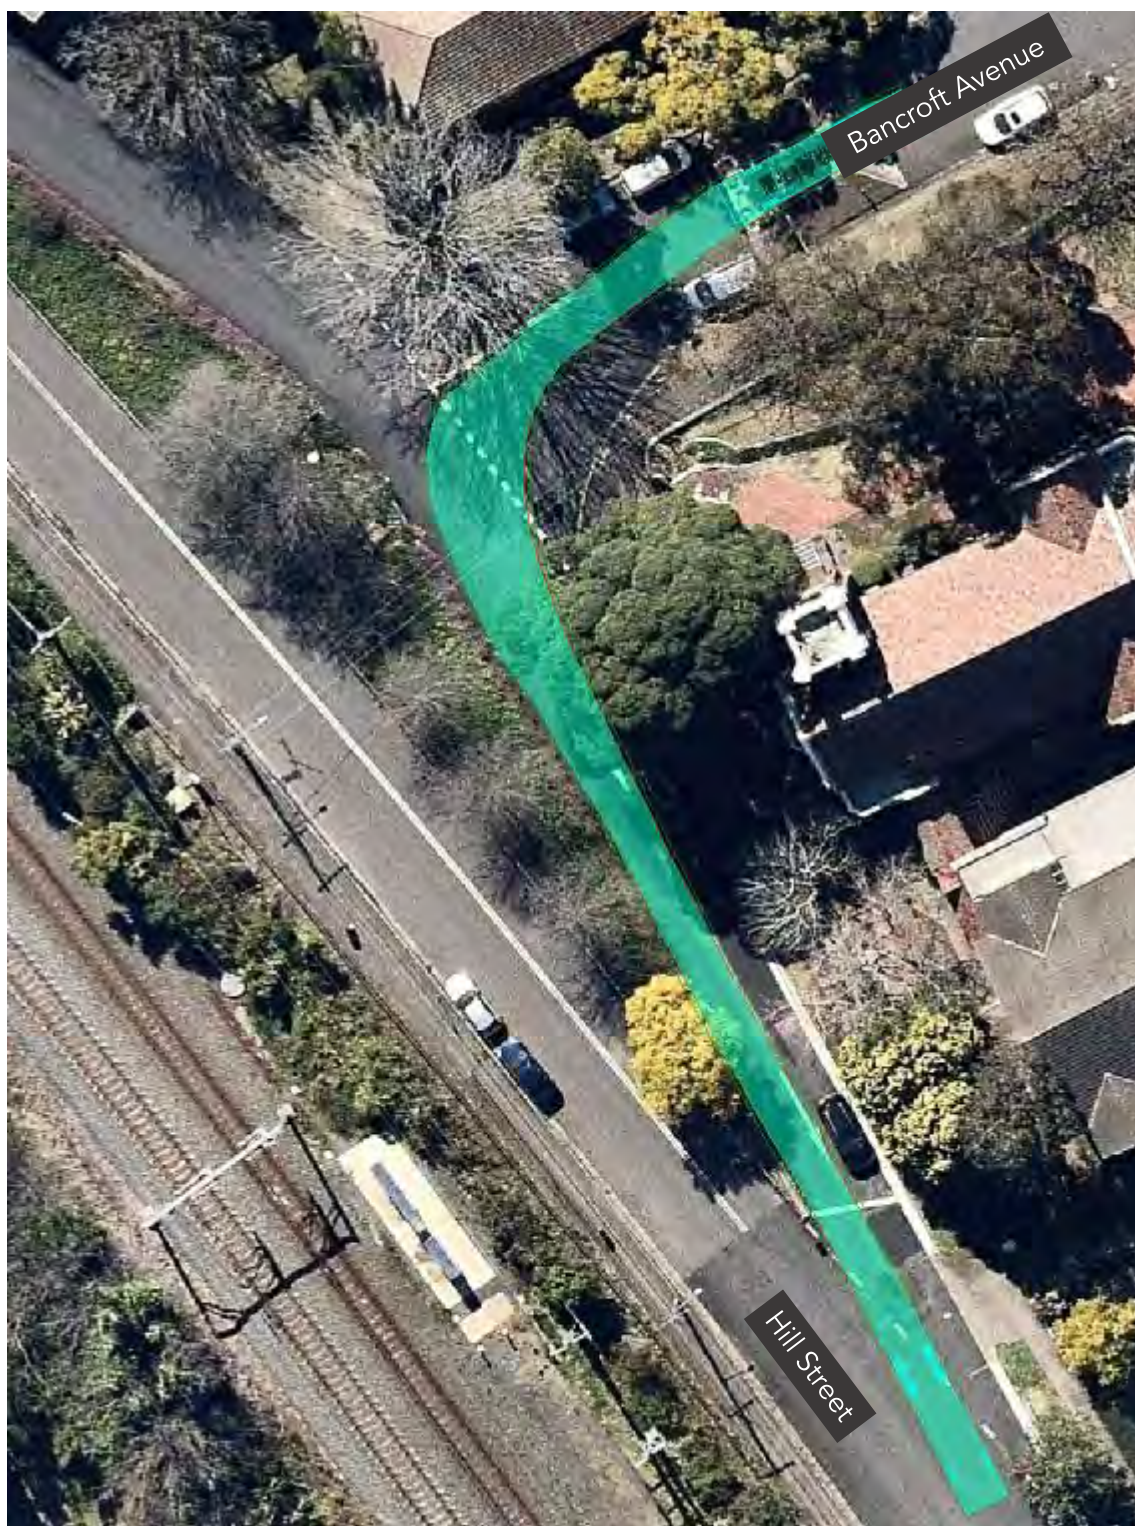
Figure 4-9 – HRV at intersection 6 (Hill Street/Bancroft Avenue)

The swept path analysis for each intersection can be found in Figure 4-8 through Figure 4-9.

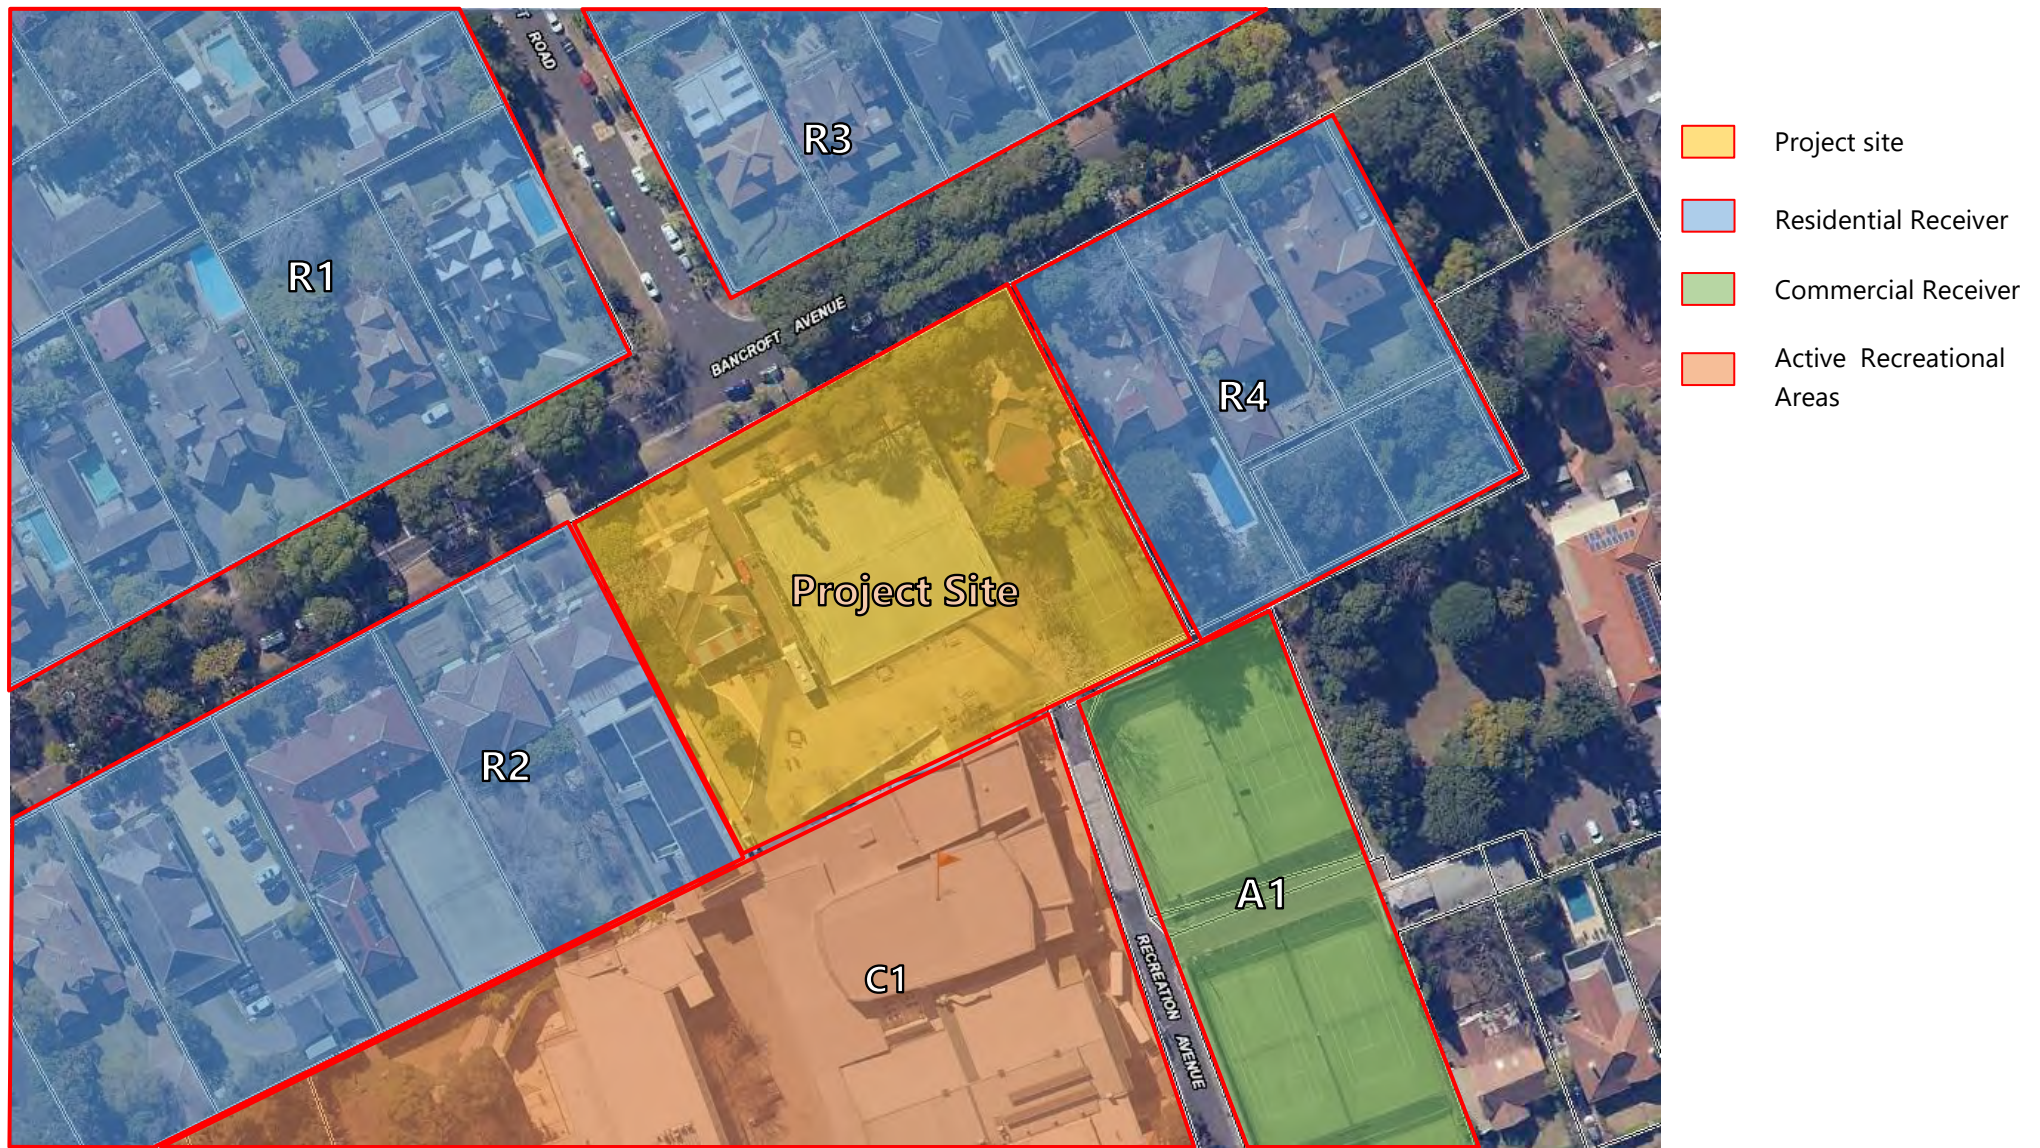
Figure 1: Aerial view of the project site and the sensitive receivers (Sourced : SixMaps)

- **R1:** Residential dwellings along the north-western boundary along Bancroft Avenue
- **R2:** Residential dwellings along the western boundary at 15-23 Bancroft Avenue, Roseville
- **R3:** Residential dwellings along the north-eastern boundary along Bancroft Avenue at 30-24 Bancroft Avenue
- **R4:** Residential dwellings along the eastern boundary at 39 Bancroft Avenue, Roseville.
- **C1:** Multi-storey commercial dwelling on the south-western boundary
- **A1:** Active recreational area on the south-eastern boundary

Refer to Figure 1 for the arial view of the project site and sensitive receivers.

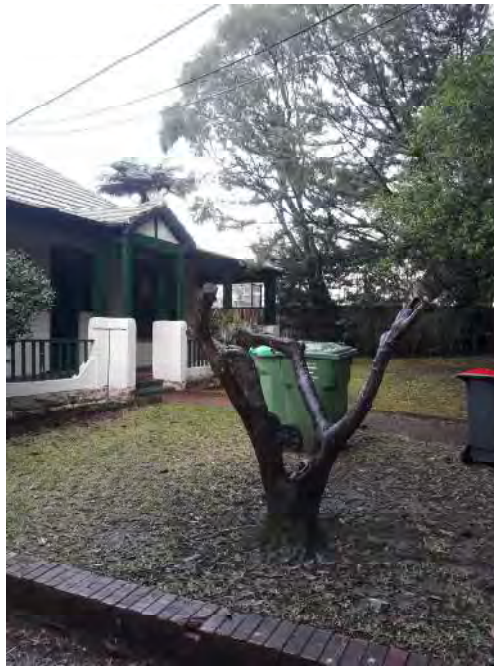
Photo 1 – Residential house (northern portion of Lot 18)

At the time of the investigation, the northern portion of Lot 18 was occupied by a residential house with a lawn and paved areas (Photograph 1). The walkover did not include an inspection of the residential house. There was a carport along the eastern site boundary. The southern portion of the lot consisted of a tennis court with a swimming pool to the east (Photograph 2). There were some mature trees, mainly along the northern and western boundary. Beyond the southern boundary of Lot 18 (Part Lot 1, D.P 133073), there was an asphaltic concrete pathway (Photograph 3).

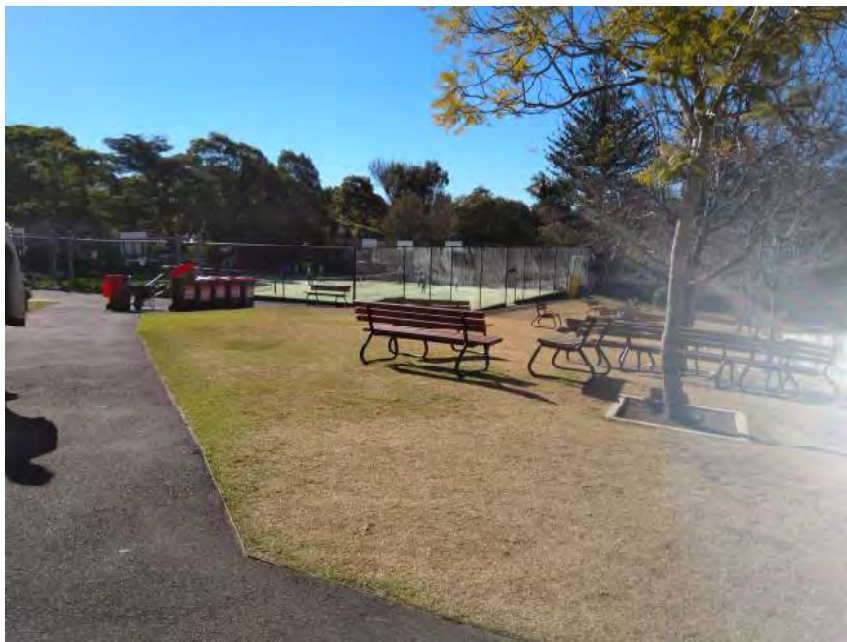
Photo 4 – Part Lot 2003.

Part Lot 2003 consisted of a tennis court with a grassed area to the south and some outdoor seating areas (Photograph 4). There was an asphaltic concrete driveway along the western site boundary.

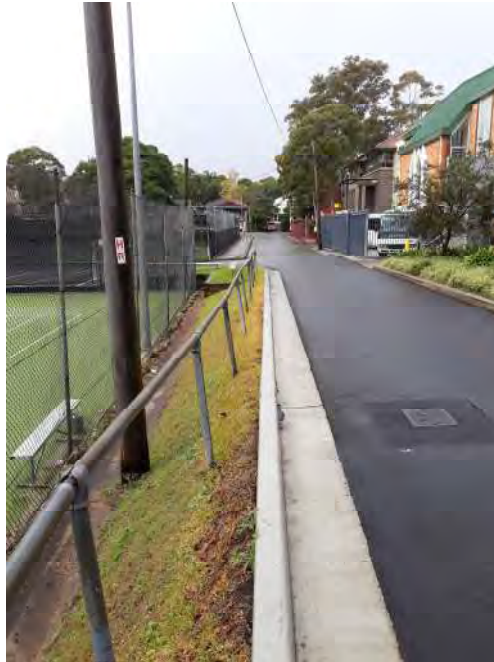
Photo 5 – Grassed batter along Recreation Avenue

The portion of Recreation Avenue within the site comprised an asphaltic concrete pavement. There was a grassed batter approximately 1 m high extending along the eastern side of the road (Photograph 5), sloping down towards the Tennis Club (Lot A, D.P 319571). A similar height, timber sleeper retaining wall was located at the northern and southern end of the eastern boundary, with backfilled material behind the wall (Photograph 6).

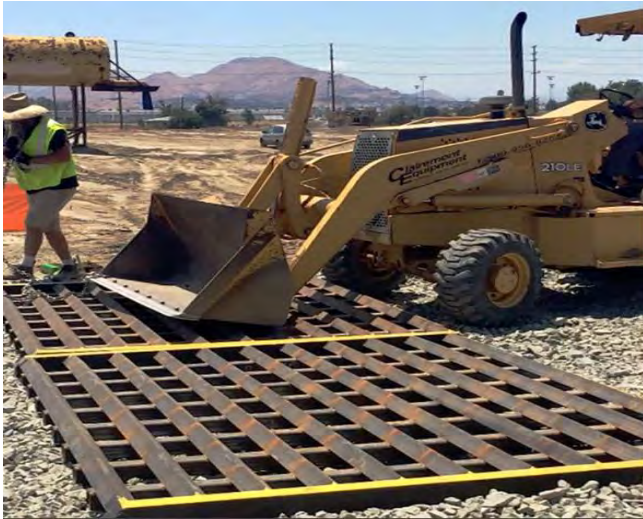
Construction and maintenance notes are provided on design drawing SY190030-C11.08.

Figure 1: Typical example of stabilised construction exit

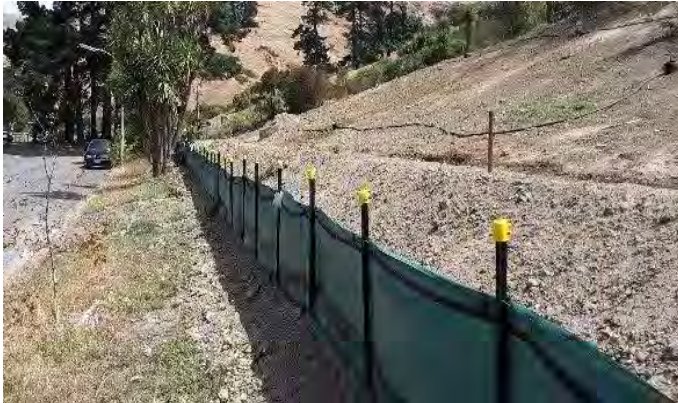
Refer to sediment fence construction notes and details on SY190030-C11.08. Location and layout of sediment fences are noted on Plan SY190030-C15.01.

Figure 3: Typical example of sediment fence

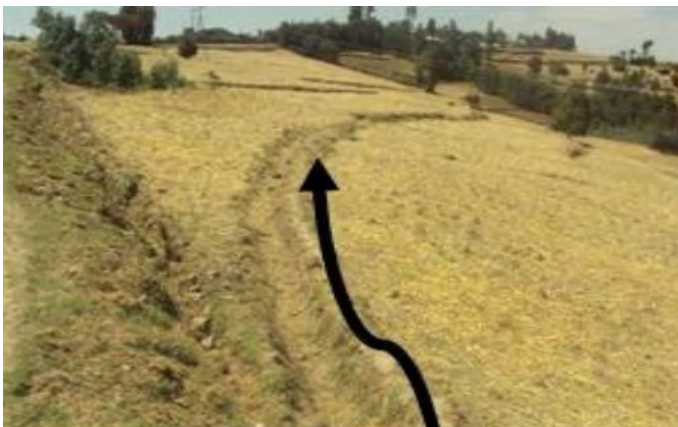
Figure 4: Typical cut off drain on site

Temporary water diversion/cut off drains are generally provided to divert upstream 'clean' surface flows around the site. Cut off drains can be constructed of a wide range of materials such as compacted earth, plastic sheeting, shortsheeting, asphalt, etc.

Cut off drains have been designed for the site to convey 10% AEP storm flows. Cut off drains shall be constructed with necessary rock check dams to ensure that the flow velocities are within the acceptable limits. Details of cut off drains and check dams are provided on drawing SY190030-C15.01 and SY190030C11.08.

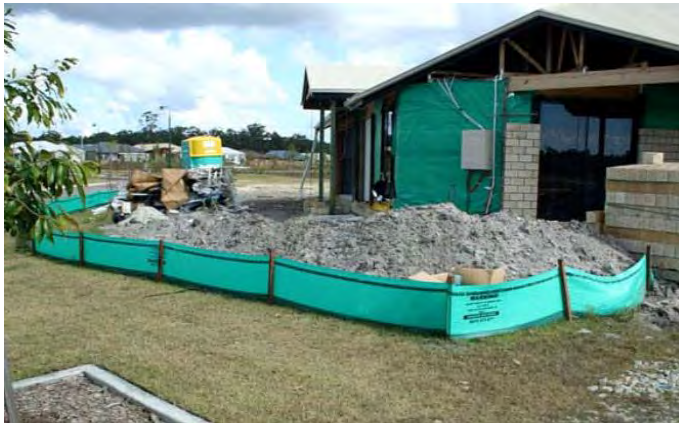
All delivery drivers shall be notified of the designated stockpile areas to deliver building materials on site. Stockpile losses can be minimised with the use of covers. A sediment fence is to be provided around the stockpiles.

Figure 5: Stockpile surrounded with a sediment fence

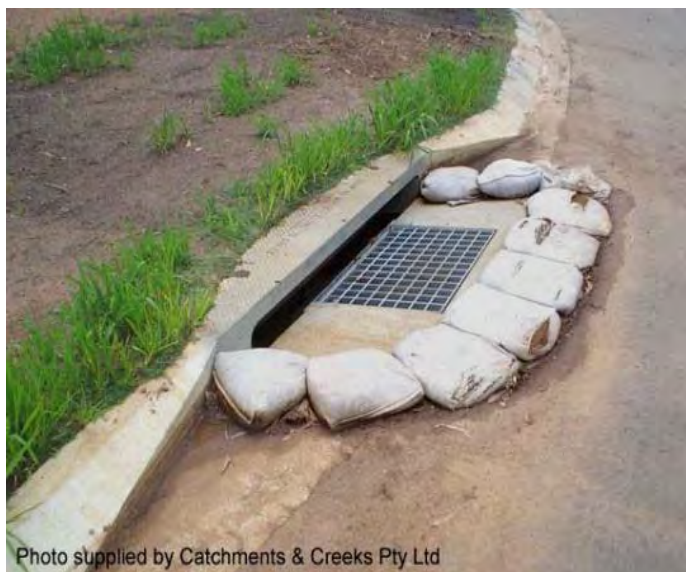
All kerb 'sag' inlet pits located at a low point in the roadway shall be protected by sandbag sediment traps. These sandbags shall be used to capture sediment and other suspended material from wash water which can be the result of concreting works on site. Geotextile sediment sandbags shall be filled with coarse sand or 15 to 25mm aggregate to perform better in public roadways. Road safety issues must be taken into consideration before the Installation of sandbags in public roads as these can easily be damaged by running traffic and can pose a traffic safety hazard. No sandbags shall be located within the road carriageway unless approval from the applicable Road Authority is obtained.

Figure 7: Typical example of sandbags surrounding a kerb inlet pit

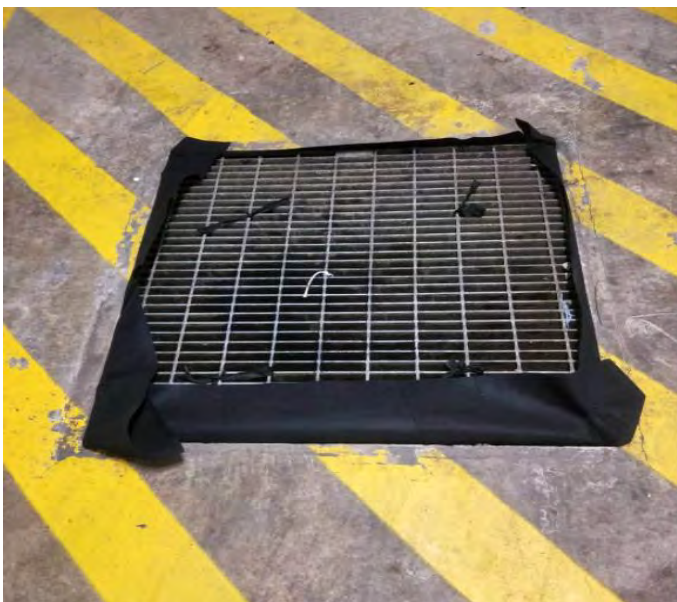
Figure 10: A typical surface inlet trap

All proposed and existing surface inlet pit openings and grates shall be wrapped in geotextile fabric until the completion of works.

Details and location of sandbag sediment trap and inlet trap are provided on drawings SY190030-C15.01 and SY190030C11.08.
