INDEPENDENT ENVIRONMENTAL AUDIT REPORT

27-29 and 37 Bancroft Avenue, Roseville

The Anglican Schools Corporation
30 July 2025
AU122160 R6

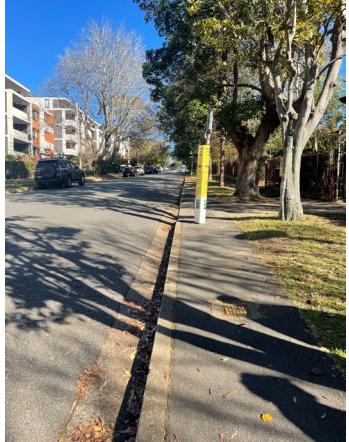
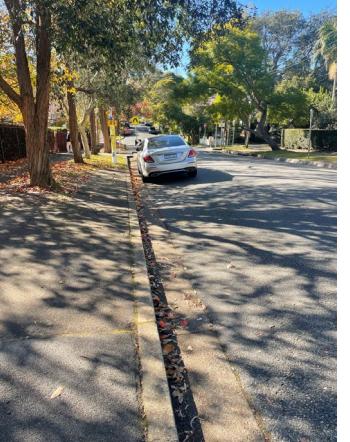
Photo Number: G7	Date: 25/06/2025

Description: The school pick-up and drop-off zone along Victoria Street observed to be able to accommodate 15 vehicles.

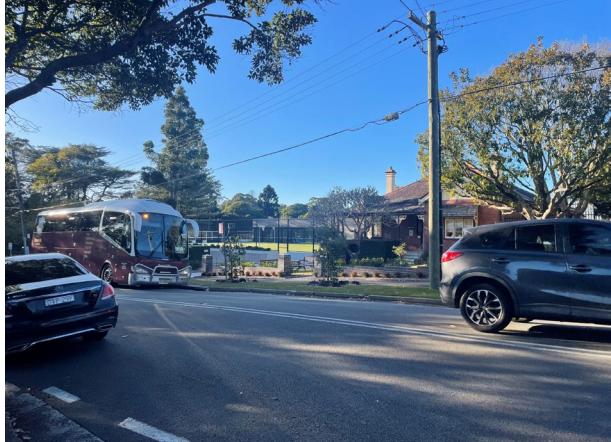
Photo Number: G119, G172	Date: 25/06/2025

Description: No roof-top acoustic barrier was observed on tennis courts. Signage illumination was not observed at Bancroft Avenue front.

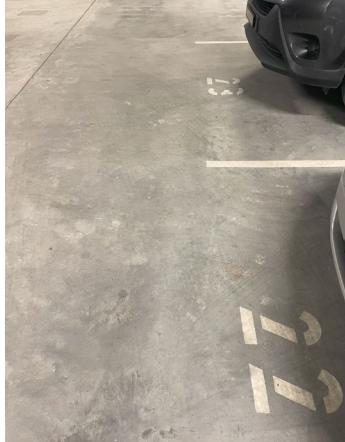
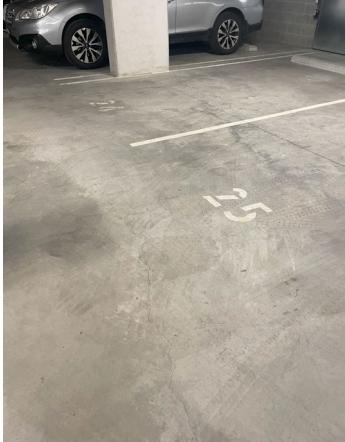
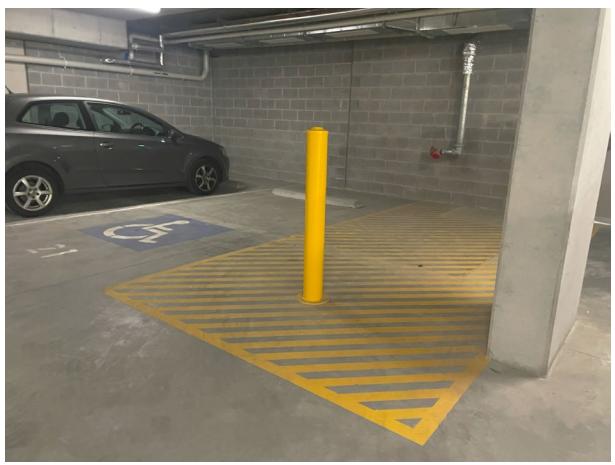
Photo Number: G128	Date: 25/06/2025

A photograph showing a concrete parking lot with several white handicapped parking symbols painted on the ground. A silver car is parked in one of these bays. The surface is textured concrete with some minor staining.
Description: Forty-eight (23 at level 1 + 25 at level 2) new unobstructed carpark were observed. Accessible carpark also observed.

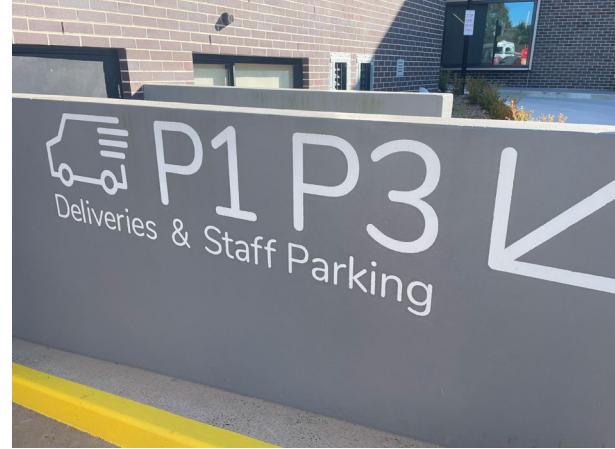
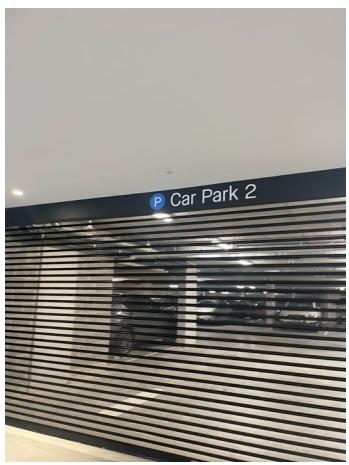
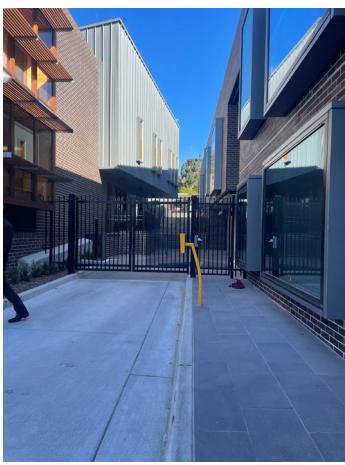
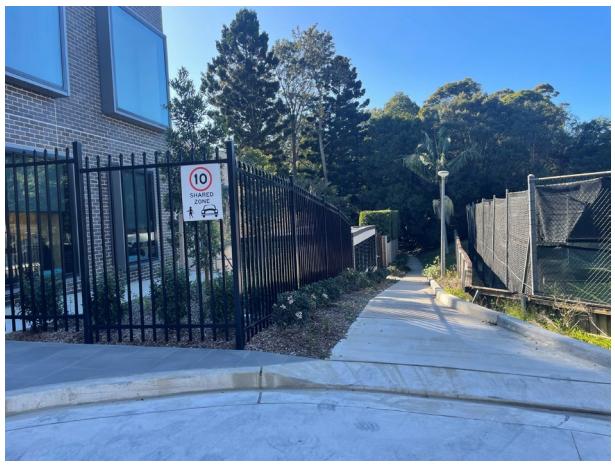
<p>Photo Number: G135, G147</p>	<p>Date: 25/06/2025</p>

<p>Description:</p> <p>Way-finding signage to staff car parking were observed to be present and well maintained.</p> <p>Driveways, footways and parking areas were observed to be unobstructed during the audit.</p>

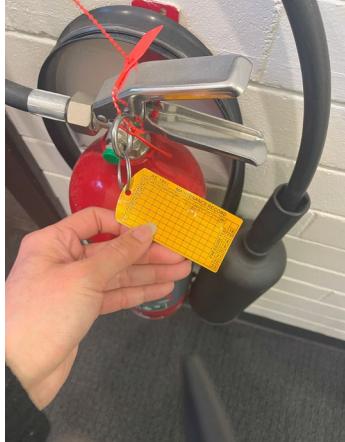
Photo Number: G141	Date: 25/06/2025

Description: Fire extinguisher tag was up to date

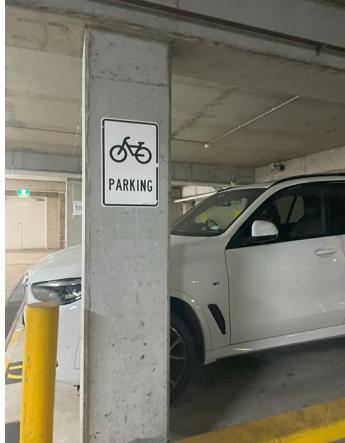
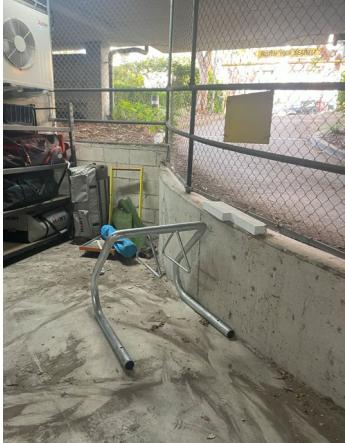
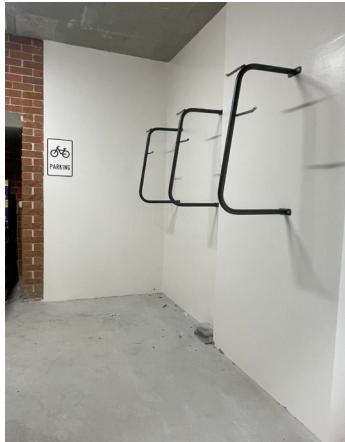
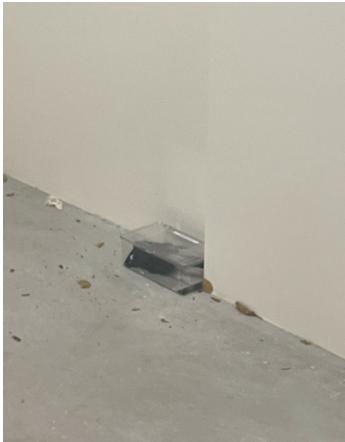
Photo Number: G175	Date: 25/06/2025

Description: Bicycle racks, signage, and bike repair tools & kits were observed.

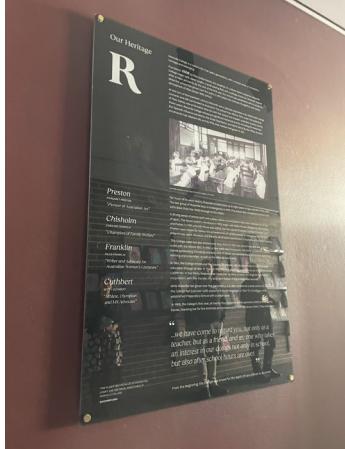
Photo Number: G179	Date: 25/06/2025

<p>Description: The interpretive display panel was observed to be well maintained.</p>

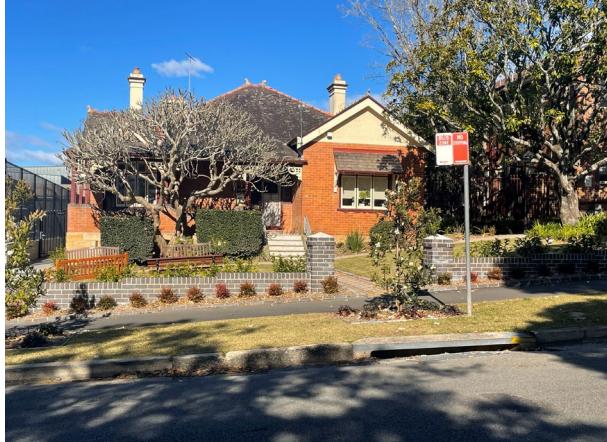
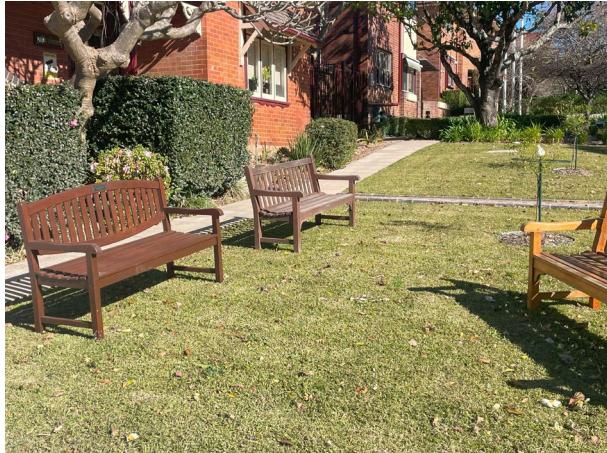
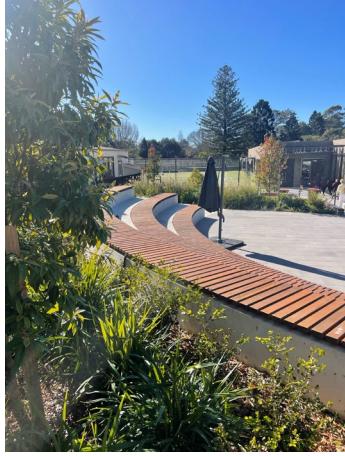
<p>Photo Number: G180</p>	<p>Date: 25/06/2025</p>

<p>Description:</p> <p>The school landscaping areas were observed to be well maintained.</p>

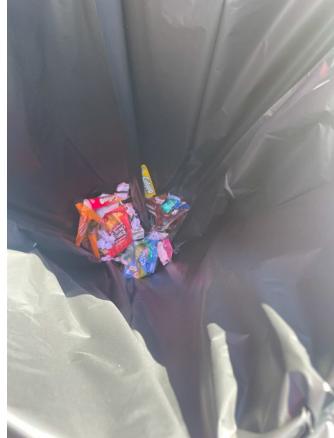
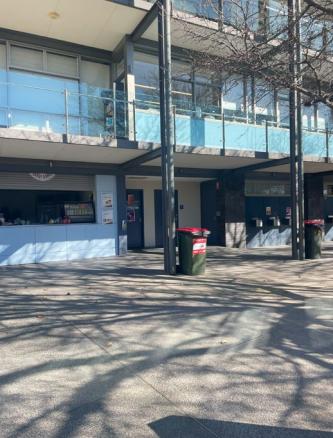
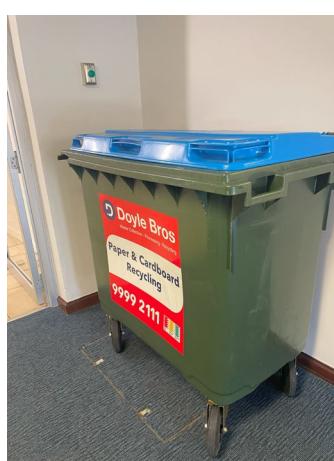
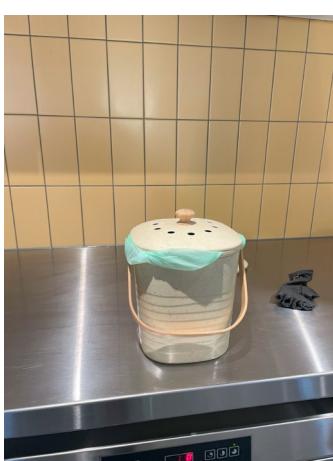
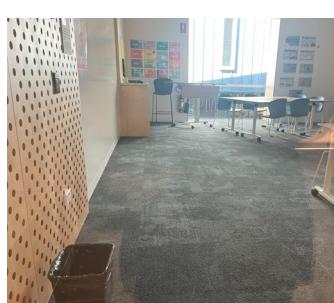
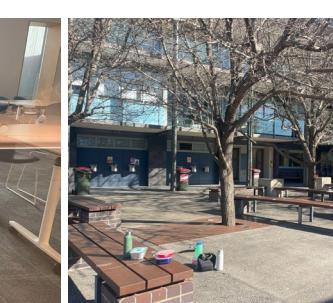
<p>Photo Number: G181, G183</p> <p>Date: 25/06/2025</p>

<p>Description:</p> <p>General bins were observed around the site including classrooms</p> <p>The bins observed were within capacity. No bin observed to be overflowing.</p> <p>MGBs (mobile garbage bin) were observed around the grounds.</p> <p>Food waste bins were observed in the food technology kitchen.</p>

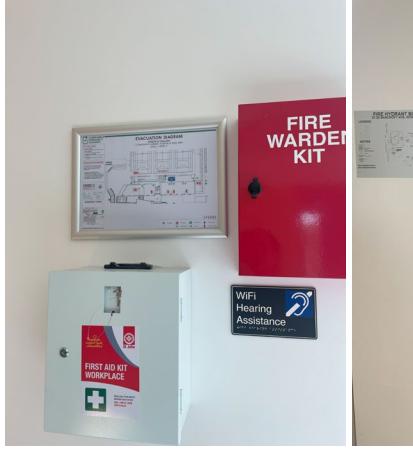
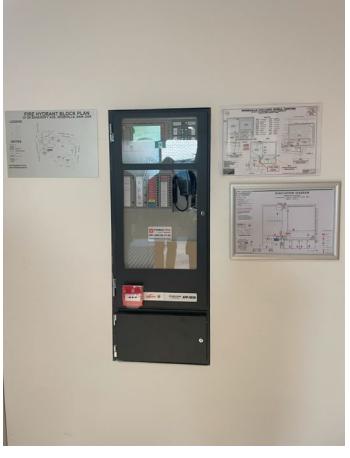
Photo Number: G184	Date: 25/06/2025

Description: Signage containing the emergency evacuation diagram was observed to be placed around the site.

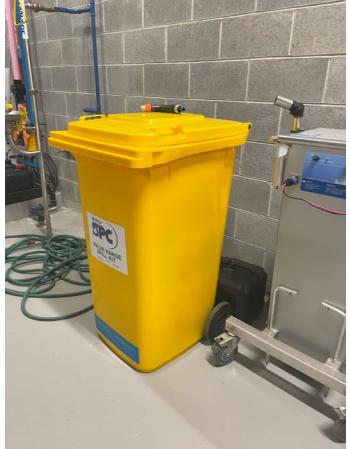
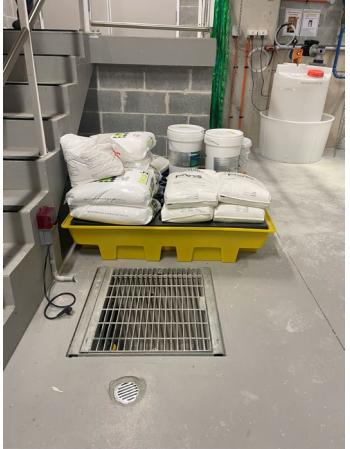
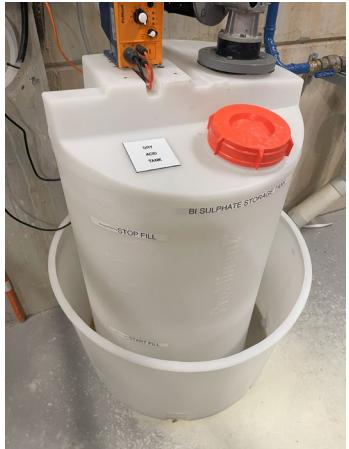
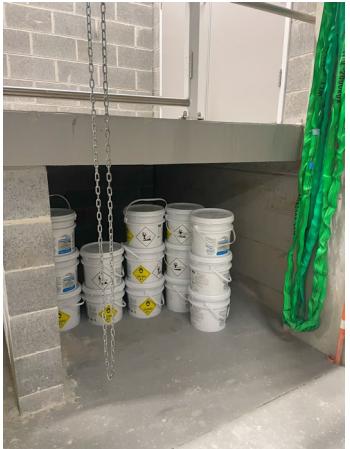
Photo Number: G154	Date: 25/06/2025

Description: Chemicals were stored in a bunded facility, spill kit, and spill kit bin were observed near the chemicals.

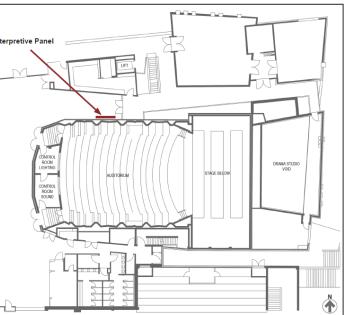
<small>Figure 4.1 Plan of level 2 of the Joy Yeo Performing Arts Centre, indicating the proposed location of the interpretive display panel. Source: Roseville College</small>
